## Water Penetration Inspection Methods for Remote Terminal Boxes

This article describes the problem of water entering remote terminal boxes and corresponding inspection methods.

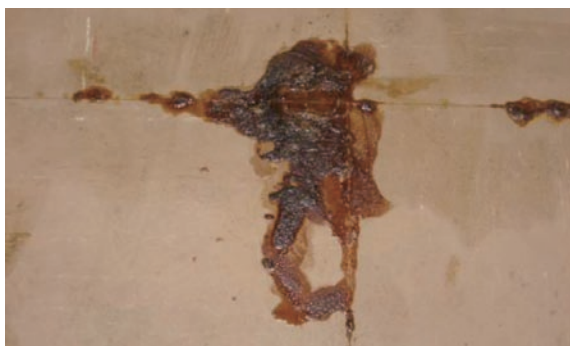
Fig. 3. Precipitate from tile joints on floor.

There have been reports of foreign matter precipitating in the joints between tiles on the floors of RT boxes (Fig. 3). When this precipitate was gathered up and analyzed, it was found to be polyacrylic acid, which is a hydrolyzed product of the acrylic adhesive used to affix the tiles to the floor. Since moisture is needed for hydrolysis, we can consider that water on the flooring material is a cause of this precipitation. Polyacrylic acid can corrode screws and materials composed of steel. Furthermore, the hydrolysis of acrylic adhesive generates not only polyacrylic acid

but also allyl alcohol, which can be harmful to humans if absorbed. To prevent both equipment and workers from being harmed by such substances, we must close off the water penetration routes. A typical water-penetration route inspection is performed as follows.

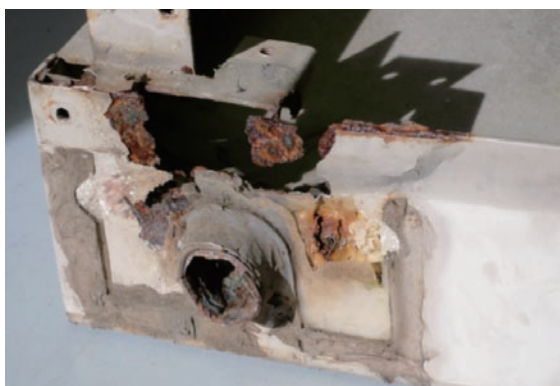
Fig. 4. Corrosion of bottom drain pan.

In this example, the exterior and interior inspections of the RT box for water-penetration routes revealed no problems in terms of housing, caulking, or cable conduits. It was thus inferred that water was probably leaking from air conditioning equipment, so the equipment's water-drainage route was inspected. The drainage route for drain water (condensation) generated in the operation of air conditioning equipment, that is, for water collecting in the bottom drain pan, is through a drain pipe that leads to the outside. When the air conditioning equipment was manually operated continuously for about two hours, careful observation of the drain pipe's drainage state did not reveal any drain water. Therefore, it was concluded that a problem probably existed with the bottom drain pan. The drainage route was inspected and it was found that water had indeed penetrated the bottom frame underneath the bottom drain pan. A further inspection of the bottom drain pan revealed corrosion in the drain outlet (Fig. 4).

corrosion inside the enclosure and generate rust in steel in the outer walls and cause peeling of exterior paint (**Fig. 6**). If the outlet of the bottom drain pan is found to be rusted, repairs should be made using putty or the drain pan should be replaced.

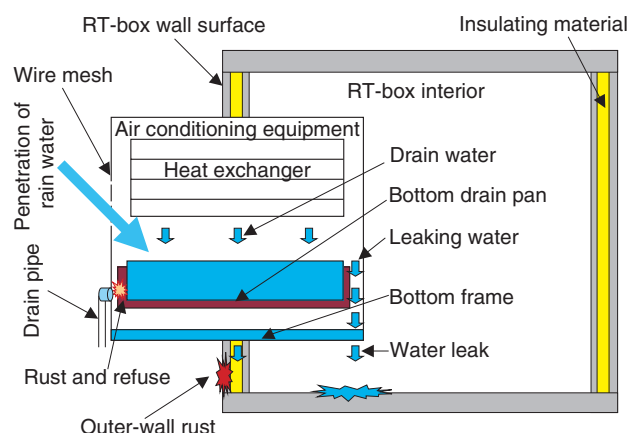
Fig. 5. Route of water leaking from air conditioning equipment.

If corrosion in the drain outlet progresses so that rust and refuse accumulate, then condensation on the heat exchanger and rain water blown in by crosswinds can overflow onto the bottom frame underneath the bottom drain pan and thereby penetrate the floor inside the RT box and the insulating material inside the enclosure walls (Fig. 5). Water that

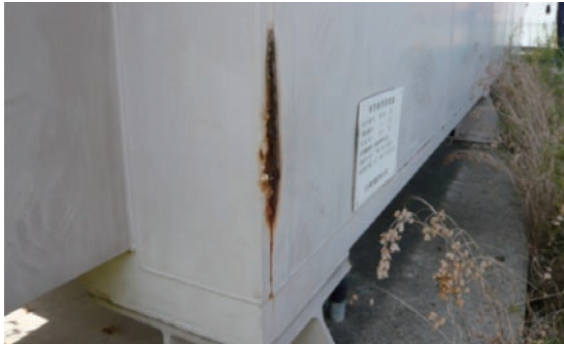
Fig. 6. Rusting and bulging of outer-wall paint.
