## Case Studies of Failures of Business Phones Connected to VoIP Gateway

This article introduces case studies of failures of business phones connected to a VoIP (voice over Internet protocol) gateway developed by NTT EAST. It is the seventh in a bimonthly series on the theme of practical field information about telecommunication technologies. This month's contribution is from the Network Interface Engineering Group, Technical Assistance and Support Center, Maintenance and Service Operations Department, Network Business Headquarters.

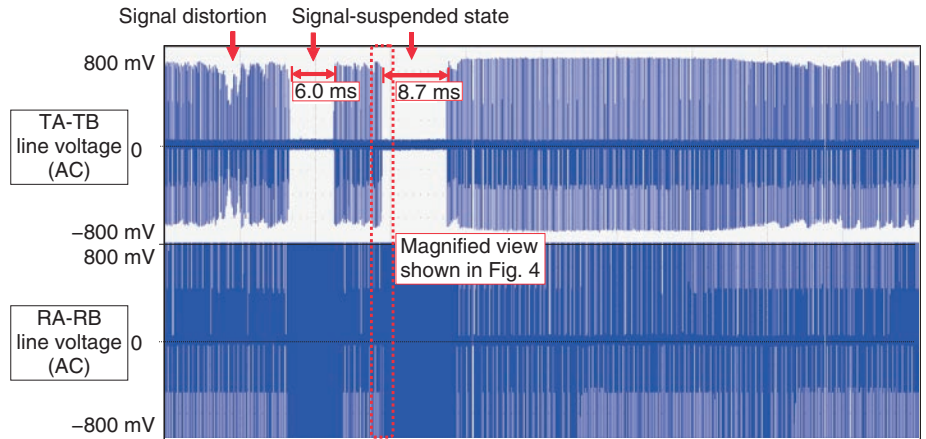
Fig. 3. Waveform at time of failure.

state of the signal transmitted from the business phone (TA-TB line signal), the VoIP-GW could not detect a frame-synchronization signal in three time-frames, which it interpreted as a frame-synchronization offset; this prompted the transmission of an INFO2 signal and the disabling of outgoing and incoming calls (**Fig. 4**).

The ISDN BRI unit connected to the business phone was replaced. This restored the line to normal operation.

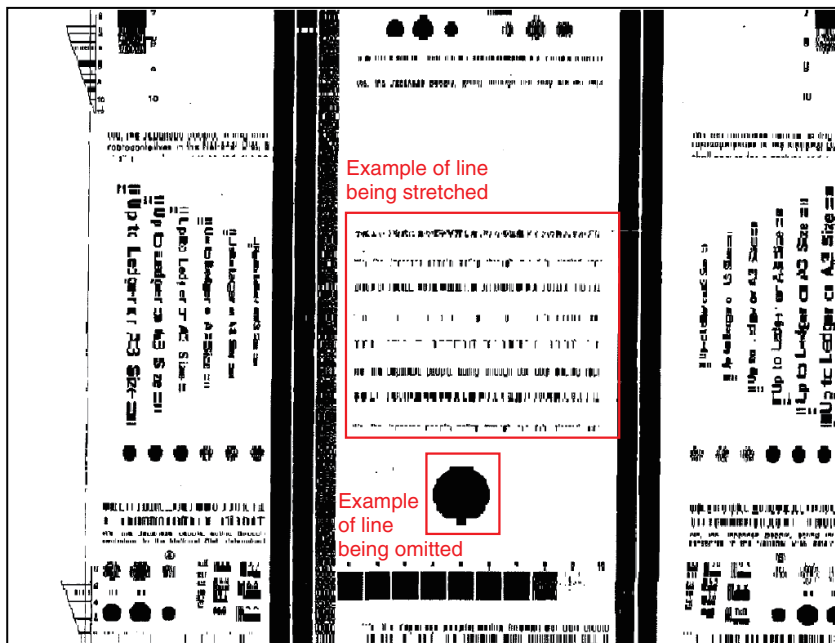
Fig. 6. Fax image received at the time of failure.

were occasionally distorted (lines stretched or omitted) and sometimes faxes could not be transmitted or received. An example of a fax image received at the time of failure is shown in Fig. 6.

This failure was considered to occur because of a mismatch in the setting covering the synchronization clock between the VoIP-GW and the main business phone unit, which led to unstable synchronization between them and degraded the transmission quality and generated defects in the fax communications.

The VoIP-GW synchronization setting was changed from slave to master so that the clock would be self-generated. This prevented this failure from reoccurring.

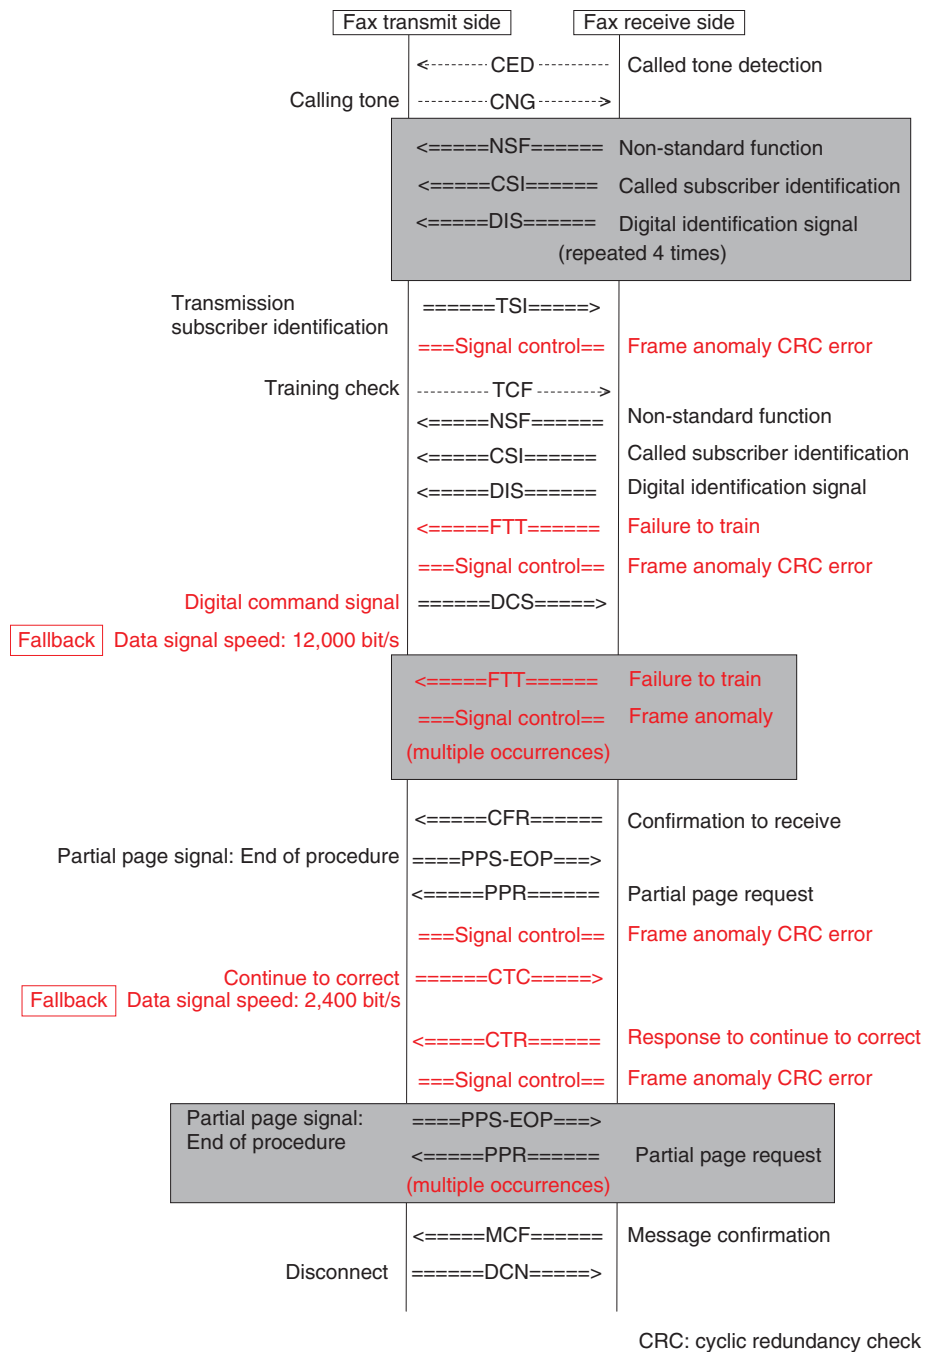
Fig. 7. Fax communication sequence at time of failure.

Monitoring of the fax communication sequence by the G3 facsimile tester revealed “failure to train”

signals, “frame anomaly” signals, and drop-in-transmission-speed sequences not observed during normal operation. The fax communication sequences at the time of failure and during normal operation are shown in **Figs. 7** and **8**, respectively. Bit-error measurements revealed a bit error rate of about 4–5% (effective number of bits:  $10^6$  in both the uplink and downlink). An analysis of captured packed data revealed no packets or sequences that could be considered abnormal. Data settings in the VoIP-GW’s ISDN interface indicated that the synchronization clock was set to slave, meaning that the clock was extracted from other equipment.
