## Cable Damage during Deicing of a Handhole

This article introduces a case study of cable damage during the deicing of a handhole and offers recommendations for damage-free deicing. It is the eleventh in a bimonthly series on the theme of practical field information about telecommunication technologies. This month's contribution is from the Materials Engineering Group, Technical Assistance and Support Center, Maintenance and Service Operations Department, Network Business Headquarters.

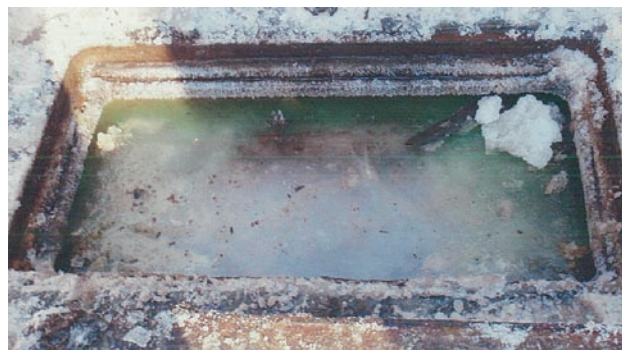
Fig. 1. Handhole prior to deicing.

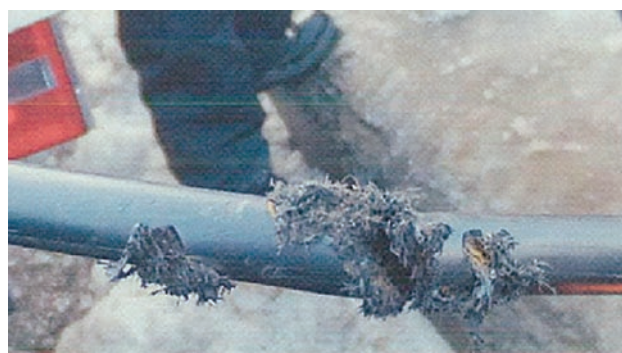
Fig. 2. Damaged optical cable with open cut.

As shown in Fig. 2, the outer sheath of the cable was severely damaged at a particular section that turned fibrous. A magnified view of the damaged section taken with a microscope is shown in Fig. 3. Apart from this section, the cable did not incur any damage, and since the boundaries of the damaged section were clearly discernible, it was surmised that the damage was caused by localized application of external physical force.

In short, we strongly recommend that the deicing of telecommunications facilities containing NTT cables should be done by spraying with unpressurized warm water (about 60°C). This method conforms to the standard NTT deicing procedure.

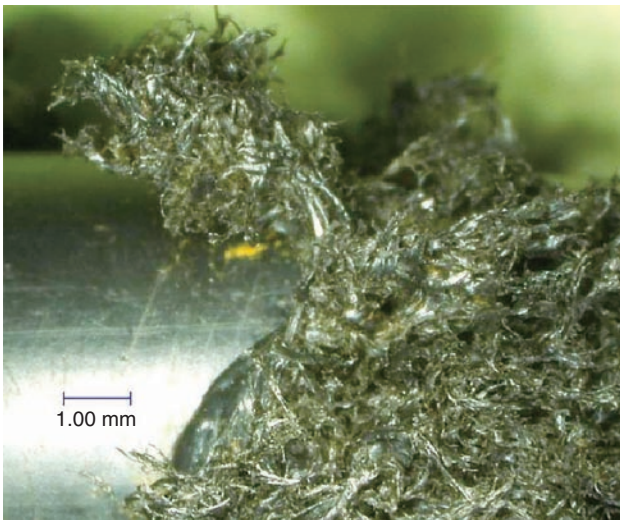
Fig. 3. Magnified view of cut in damaged optical cable.

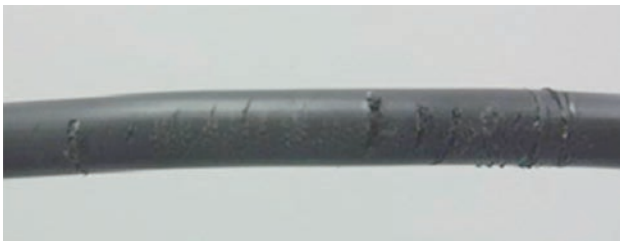
Fig. 4. Cable damaged by a sharp-edged object.

Since the mechanical outer damage might have been caused by deicing tools, we guessed that the deicing in this case was performed using either a sharp-edged tool conveniently at hand or a special-purpose deicing scraper onsite. However, when we scraped at the outer sheath of the cable using a saw-like tool, we found that only simple cuts were formed without any fibrous threads (Fig. 4).

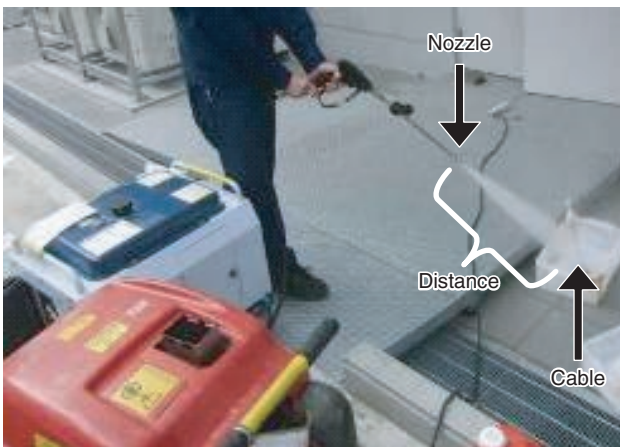
Fig. 5. Damage-reproduction experiment using a high-pressure water sprayer.

NTT-related business operators perform the same kind of deicing operation by spraying unpressurized warm water at a temperature of about 60°C. However, because a high-pressure water sprayer was used at the time of the accident, we decided to use a machine of the same type in an experiment designed to try and reproduce the damage. Specifically, we used a high-pressure water sprayer (Seiwa Sangyo jet-boiler/jet-clean product) to spray a new 40SM-WBB cable on the premises of the Technical Assistance and Support Center (Fig. 5). In this experiment, we varied two parameters: the nozzle pressure and the distance between the nozzle and cable. The results are given in Table 1.

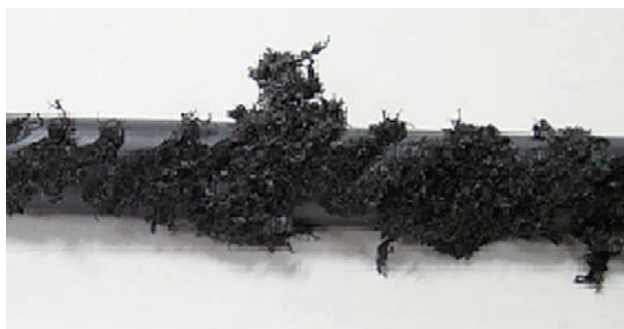
Initially, we set the water temperature to about 30°C and nozzle pressure to 18 MPa and reproduced the working conditions at the site of the accident. We found that spraying the cable with water for 15 s from a distance of 5 cm damaged the outer sheath of the cable turning it fibrous, as shown in Fig. 6. From this result, we concluded that deicing performed using a high-pressure water sprayer was the cause of the damage in this incident.

Fig. 6. Cable with damage reproduced (18 MPa, 30°C, 5 cm).

From our experimental results, we conclude that using a high-pressure water sprayer to deice a hand-hole can damage a cable and turn its outer sheath fibrous. We also found that such damage can be avoided by reducing the pressure of the high-pressure water sprayer to 4.5 MPa or setting the distance from the nozzle to the cable to 30 cm or greater. However, as actual conditions may differ depending on equipment specifications such as the shape of the nozzle tip, it is not possible to firmly establish safe parameters for using a high-pressure water sprayer. We therefore recommend that the use of a high-pressure water sprayer be avoided if at all possible.
