Failure Cases in Access Facilities (Aerial Metallic Communication Facilities) and Countermeasures

In this article, we introduce failure cases in access facilities (aerial metallic communication facilities) and countermeasures to them. This is the eighteenth in a bimonthly series on the theme of practical field information on telecommunication technologies. This month's contribution is from the Access Engineering Group, Technical Assistance and Support Center, Maintenance and Service Operations Department, Network Business Headquarters, NTT EAST.

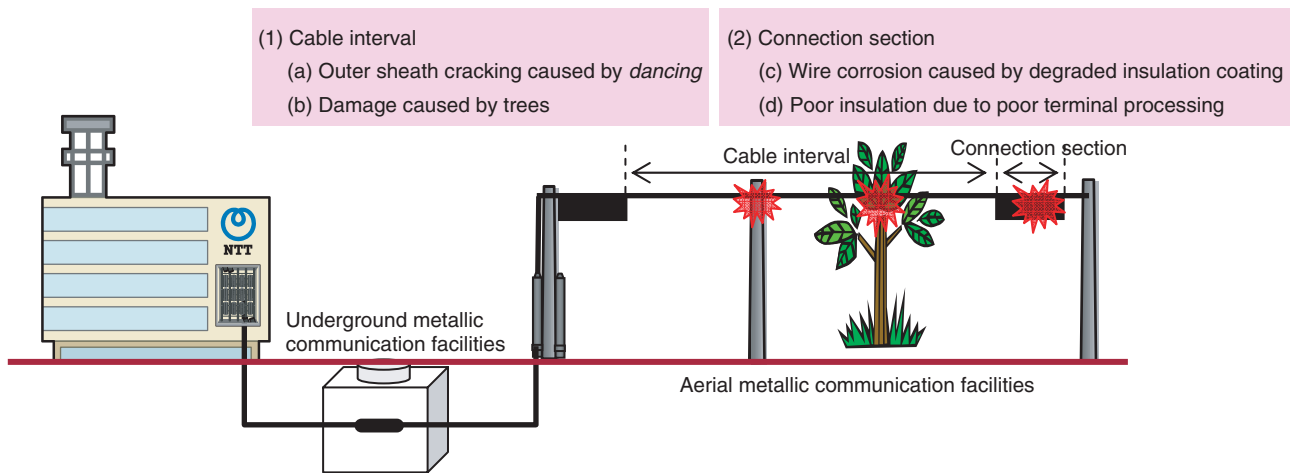
Fig. 2. Examples of failures in aerial metallic communication facilities.

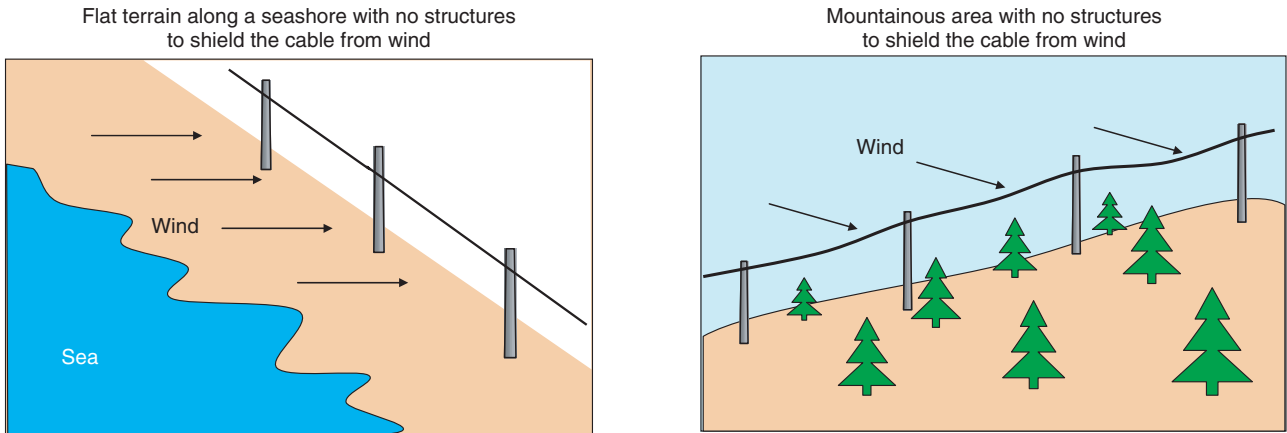
In regions affected by strong winds, dancing* (Fig. 3) in a self-supporting (SS) cable, especially a small-diameter one, may cause the outer sheath to crack (forming a ring-shaped cut) at the position where the cable is separated from its support line.

Fig. 3. Types of terrain conducive to dancing phenomenon in cables.

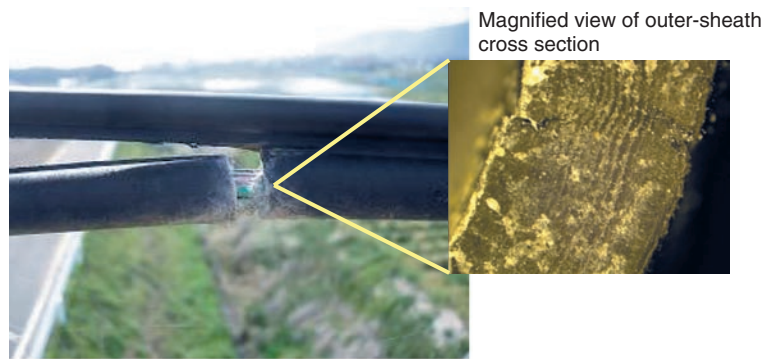
Outer sheath cracking in a color coded polyethylene (CCP) cable due to a ring-shaped cut is shown in Photo 1, and the mechanism generating this cracking is shown in Fig. 4. Along seashores or other places where there are no structures (intermediate pillars) to shield the cable from wind, the cable's outer sheath can be damaged in a circumferential direction at the

Photo 1. Outer sheath cracking by ring-shaped cut.

position where the cable is separated from the support line. This damage features circular fracture marks that are similar in appearance to annual growth rings in trees.

Apply cable binding string to existing cable

This countermeasure can be applied to cable routes on which outer sheath cracking has previously occurred in CCP-SS cables because of strong winds or other factors or on routes where such damage is likely to occur. The application of cable binding string disperses the maximum strain occurring at the position where the cable separates from the support line and therefore controls the cable's degree of freedom at the section where it is suspended at the utility pole. This produces a strain-easing effect, which is why binding using cable binding string is important (Fig. 5).

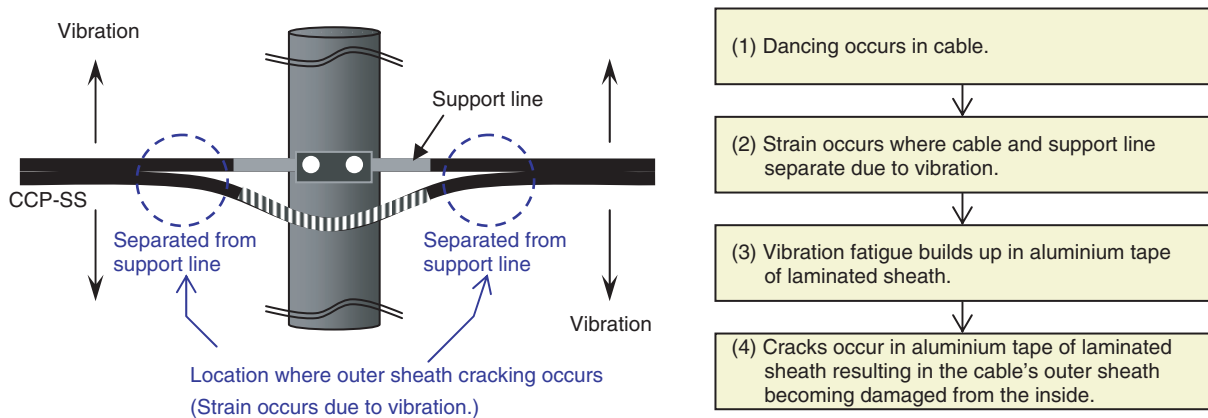
Fig. 4. Generation of outer sheath cracking in CCP-SS cable.

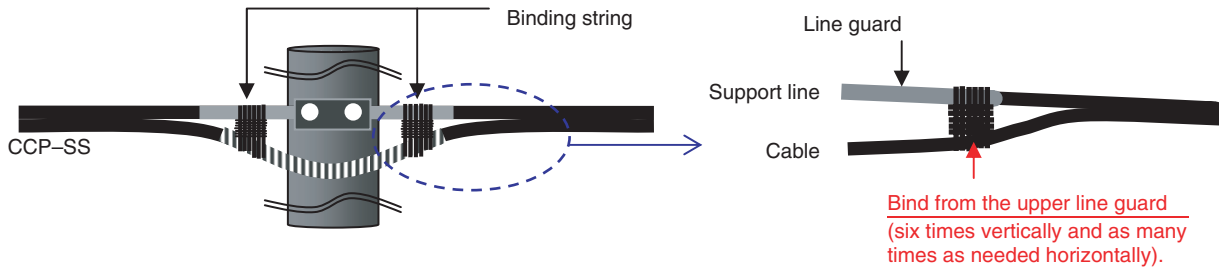
Fig. 5. Ring-shaped cut countermeasure using cable binding string.

Install binding so that the gap between the support line and cable does not fluctuate before and after the binding.

- (1) Use cable binding string to bind the cable to the end of the upper line guard.
- (2) Wrap binding string six times vertically and as many times as needed horizontally so that the gap between the support line and cable does not fluctuate before and after the binding.

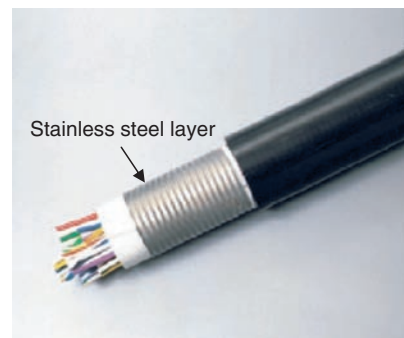
Photo 2. Appearance of HS cable

The use of high-strength CCP-HS-SS cable reinforced with a stainless-steel layer is an effective countermeasure against outer sheath cracking when installing new cable or upgrading existing cable when conditions (A) or (B) below apply (Photo 2).

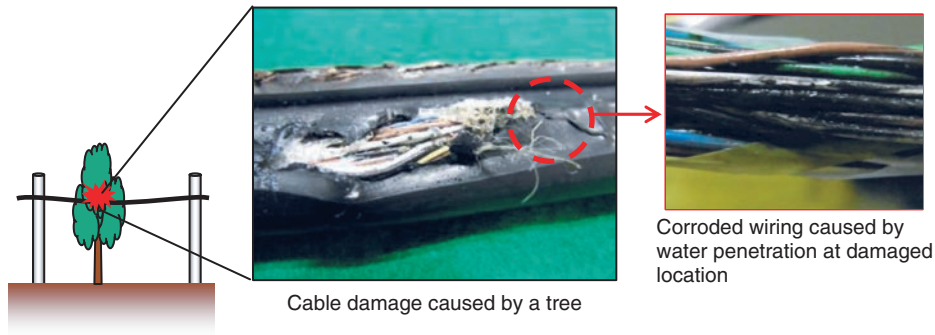
Photo 3. Example of cable damage from a tree.

that rubs up against the cable’s outer sheath in such a way that even core wires can be negatively affected. An example of cable damage caused by a tree is shown in **Photo 3**. Although the search for faulty core wires along the span of a suspended cable can be narrowed down through a standard conduction check, isolating the exact failure location often requires a visual inspection and a great deal of labor. Some phenomena have been reported in which the damage is such that the problem can only be resolved by replacing the cable and not by simply repairing the damaged location. For example, a cable installed on an inclined route will naturally have a height difference along its span, and it has been found that core wires on the side below the damaged location can become corroded and generate disconnection failures (**Fig. 6**).

Some form of protection may be applied in loca-

tions where cables and trees come into contact with each other, or trees in the immediate area may be cut down as a preventive measure against outer sheath damage.

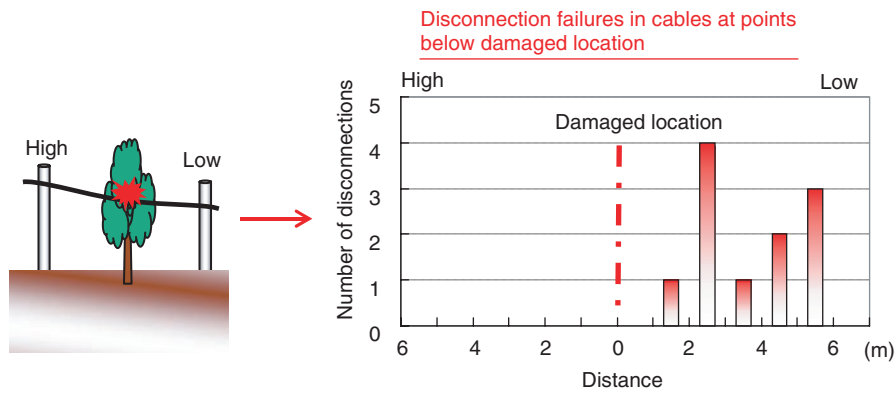
Fig. 6. Disconnection failure in cables on inclined routes.

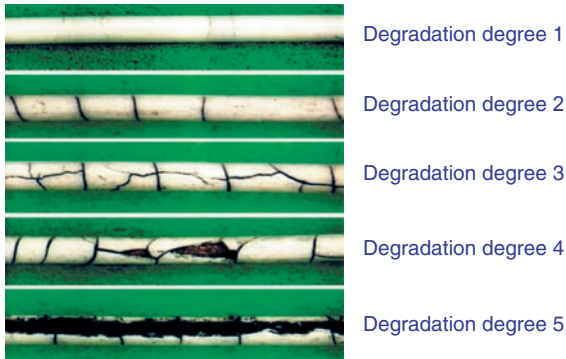
Core wire insulation (polyethylene) in CCP cables can deteriorate for various reasons including high temperatures, humidity, and sea-salt particles that get inside a terminal box. Furthermore, infiltration of ultraviolet light into a terminal box through gaps caused by deformation in the terminal-box cover or side panels resulting in poor sealing—which was rarely seen in older types of terminal boxes—can accelerate such insulation degradation. Moreover, fractures have become quite noticeable in core wires in non-black colors that absorb a large portion of

Photo 4. Classification of core wire degradation.

ultraviolet light (**Photo 4**).

The use of humidity controlling materials and life-extending terminal boxes can be used as countermeasures to core wire corrosion. Humidity controlling materials adjust the peripheral humidity and prevent condensation on core wires, which makes them effective in suppressing insulation degradation and failures. They are applicable to insulation that has a

degree of degradation of 1 or 2. In the event of core-wire insulation having a degree of degradation of 3, 4, or 5, the existing terminal box can be replaced with a life-extending terminal box and wires inserted accordingly to ensure long-term reliability. Humidity controlling materials are shown in **Photo 5**, the implementation of a countermeasure to core-wire insulation faults using humidity controlling materials is shown in **Photo 6**, and a repair method using a life-extending terminal box is shown in **Photo 7**.

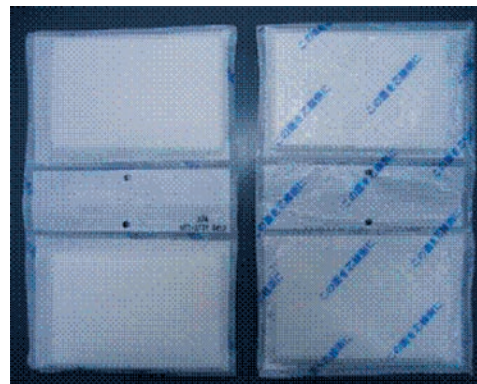
Photo 5. Humidity controlling materials.

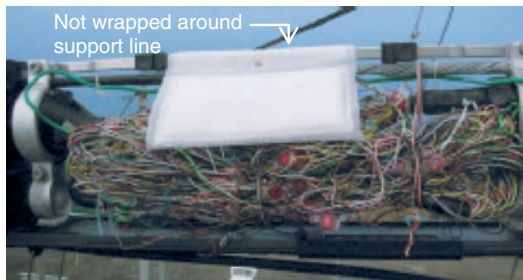
Photo 6. Countermeasure to core-wire insulation faults using humidity controlling materials.

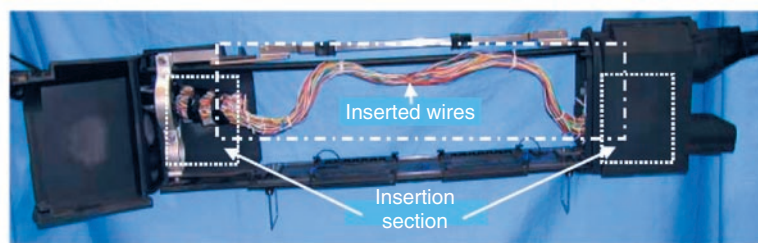
Photo 7. Repair technique using a life-extending terminal box.

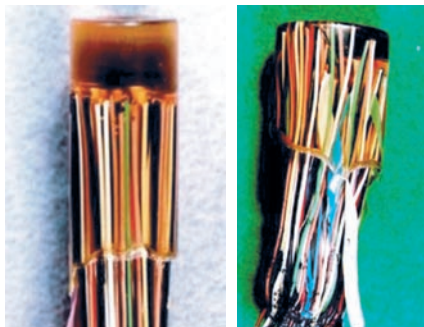
- (1) Hardening faults due to insufficient stirring of the liquid A/B epoxy resin, which is used to protect the edges of core wires (naked copper wire) against humidity or other materials that can cause corrosion or unwanted contact between wires
- (2) End of core wires coming into contact with the bottom of the sleeve
- (3) Water penetration due to direction errors at the top and bottom of the sleeve

Correct processing Incorrect processing
 →Wires touch the bottom of the sleeve, causing mutual conduction.

Photo 8. Examples of terminal sleeve processing.

- (1) Stir liquid A/B epoxy resin well so that no unreacted hardening agents remain.
- (2) Let the end of core wires float about 1 cm from the bottom of the terminal sleeve.
- (3) Turn the terminal sleeve upside down immediately after processing so that its bottom is oriented upward.

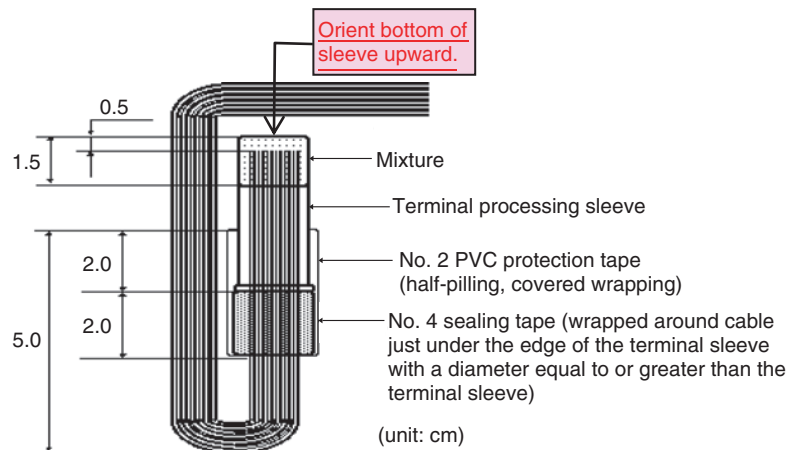
Fig. 7. Schematic of terminal sleeve processing.

A schematic of terminal sleeve processing is shown in **Fig. 7**. The following points should be kept in mind when processing the terminal sleeve:
