Lightning Damage and Mitigation in Telecommunication Access Installations

Keywords: countermeasures, lightning damage, telecommunication access installations

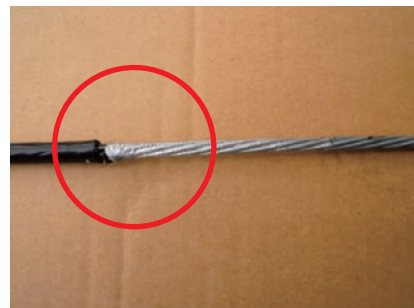
tions. An example of damage caused by a lightning strike to the messenger wire used for fixing the telecommunication cable is shown in **Fig. 1**. Under the assumption that a large current flows as a result of such a lightning strike, it is expected that significant damage to the messenger wire will remain and that the messenger wire will degrade faster than usual.

Fig. 1. Damage to messenger wire.

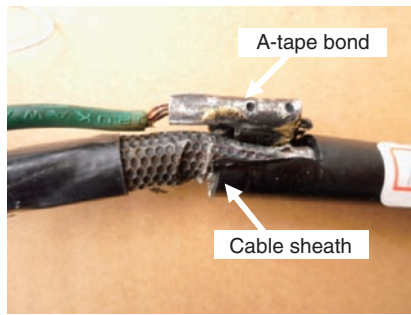
One phenomenon, namely, damage to a connection between a cable sheath and a ground wire bonded by aluminium tape (hereafter called an A-tape bond) in the splicing closure that connects telecommunication cables, is shown in **Fig. 2**. This phenomenon may potentially cause failure of the insulation between the core wires in the cable. Another phenomenon, that is, the surface damage of a CP, is shown in **Fig. 3**. This

Fig. 2. Damage to connection between cable sheath and A-tape bond.

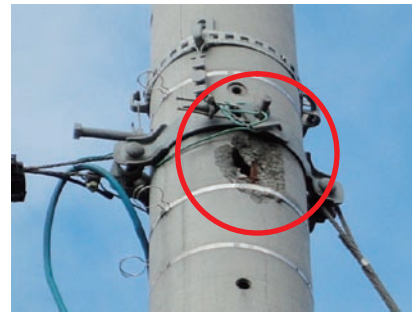
Fig. 3. Damage to CP (detachment of concrete from surface of CP).

phenomenon makes it necessary to erect a new CP sometime in the future. Damage presumed to be caused by these phenomena related to lightning strikes often occurs on the telecommunication access installations located near high-rise buildings. Accordingly, understanding the mechanism that causes lightning damage to such installations and devising coun-

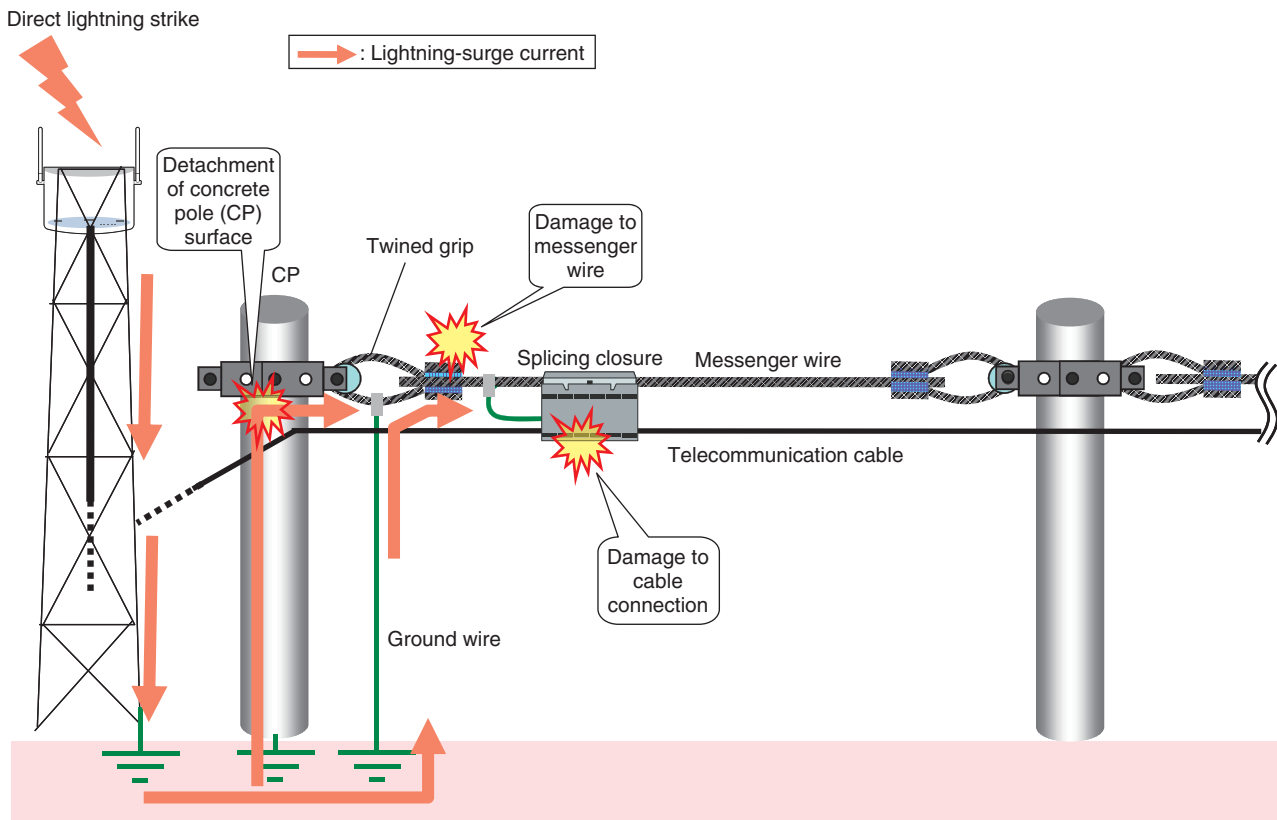
Fig. 4. Configuration of telecommunication access installation and presumed routes of lightning-surge current.

The mechanism of the lightning damage that occurs in the above-described configuration is explained as follows. When the lightning directly strikes a high-rise building, a lightning-surge current is propagated through the building and flows to ground. Part of the surge current flowing to ground flows in the opposite direction, namely, up the ground line, as a backflow current. The surge current that flows into the ground wire then flows into the messenger wire via the twined grip. The energy generated by this surge current exceeds the surge capacity of the messenger wire, which is thereby damaged [1]. Furthermore, if the energy of the surge current flowing in the messenger wire exceeds the surge capacity of the A-tape bond, the connection of the cable sheath and the A-tape bond heats up and becomes damaged [2]. In addition, the flow of the lightning-surge current to ground raises the electrical potential of the ground. As a result, an overvoltage is applied to the concrete medium between the support bands and reinforcing bars of the CPs. As a result of this overvoltage, the insulation provided by the concrete breaks down, and the concrete surface of the CPs detaches in places [3].

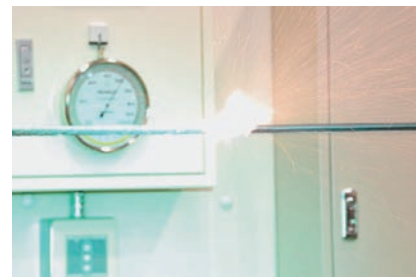
Fig. 6. Spark discharge at the time of lightning surge application.

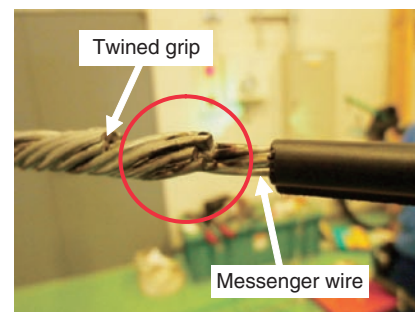
Fig. 7. Result of reproducing degradation of messenger wire.

and traces of the electrical discharge remain on the messenger wire as shown in Fig. 7. The electrical discharge occurs near the connection between the messenger wire and the twined grip, and the peak value of the current wave at the time of discharge is 23.8 kA.

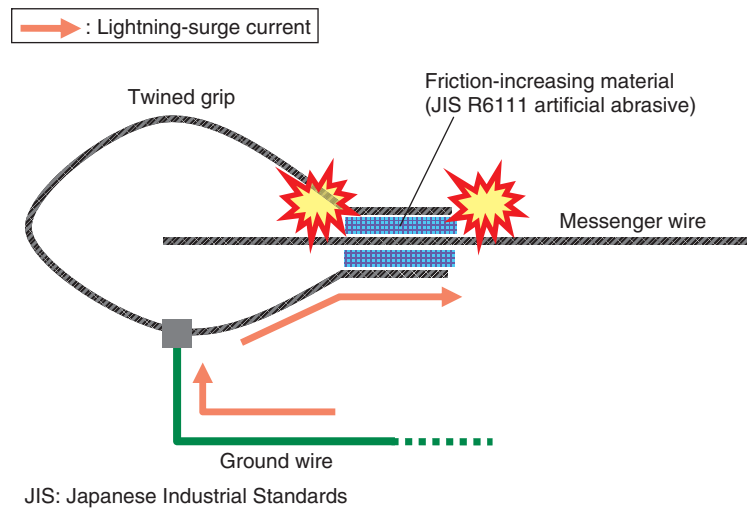
Fig. 8. Electrical discharge in the vicinity of the connection of the messenger wire and the twined grip (enlarged).

In order to prevent a disconnection at the twined grip and the messenger wire, friction-increasing material (artificial abrasive JIS R 6111) is coated on the internal surface of the spiral part of the connection (**Fig. 8**). Because of that coating, a gap is formed in the connection, and that gap is thought to make it easier for spark discharge to be generated by the surge current. Consequently, it is thought that damage to the messenger wire such as corrosion of the wire

itself and degradation of the zinc coating will remain, and the messenger wire will deteriorate faster than normally expected.

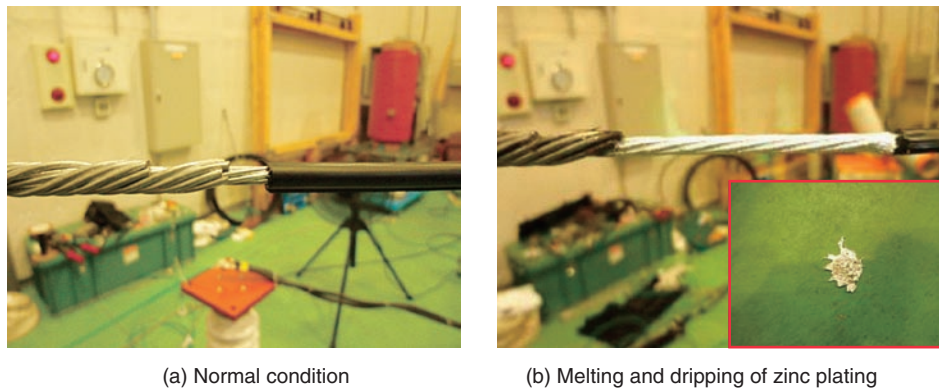
Fig. 9. Example of experimental result.

The peak current value of the direct lightning strike is generally several dozen kiloamperes (kA). During the winter in the regions along the Sea of Japan, however, on rare occasions, lightning strikes with current-wave peaks exceeding 100 kA have been measured. When such a large current flows in the messenger wire, the kind of damage that occurs also depends on the duration of the current flow. In this experiment, we confirmed the phenomenon in which the zinc-aluminum-alloy coating on the messenger wire melted and dripped onto the ground (**see Fig. 9**).
