## Examples of RT-BOX Deterioration and New Inspection Method

*Keywords: RT-BOX, corrosion, inspection manual*

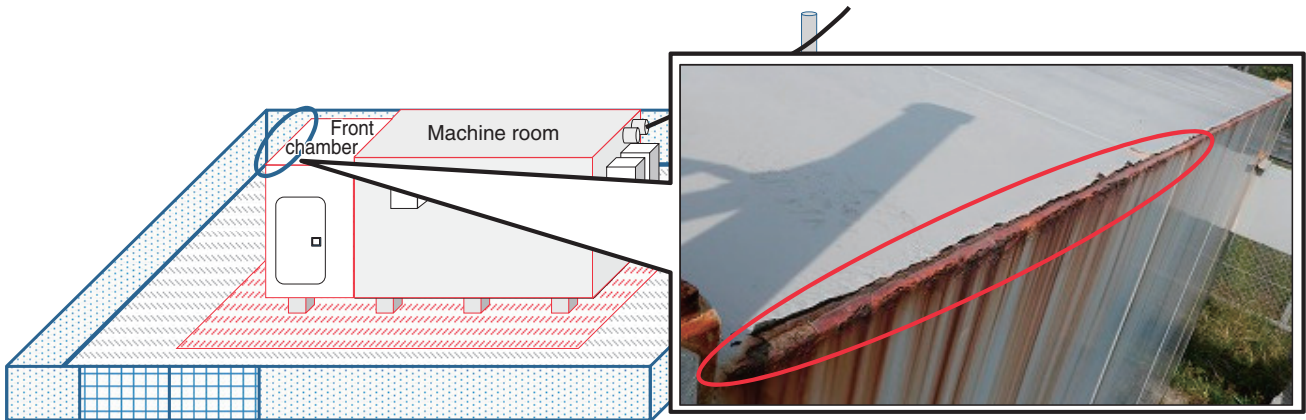
Examples of deterioration in steel, paint, and caulking commonly seen in RT-BOX housing are shown in **Figs. 2–4**. The tendency of paint to deteriorate at corners and uneven sections of the RT-BOX housing can be seen. This is because applied paint easily thins out at corners and uneven sections and because stress concentrates at such locations along with the expansion and contraction of steel due to outside air temperatures. Furthermore, the deterioration or peeling of caulking can drive the corrosion of steel as described above, so special attention is needed here.

Fig. 2. Example of deterioration in RT-BOX steel.

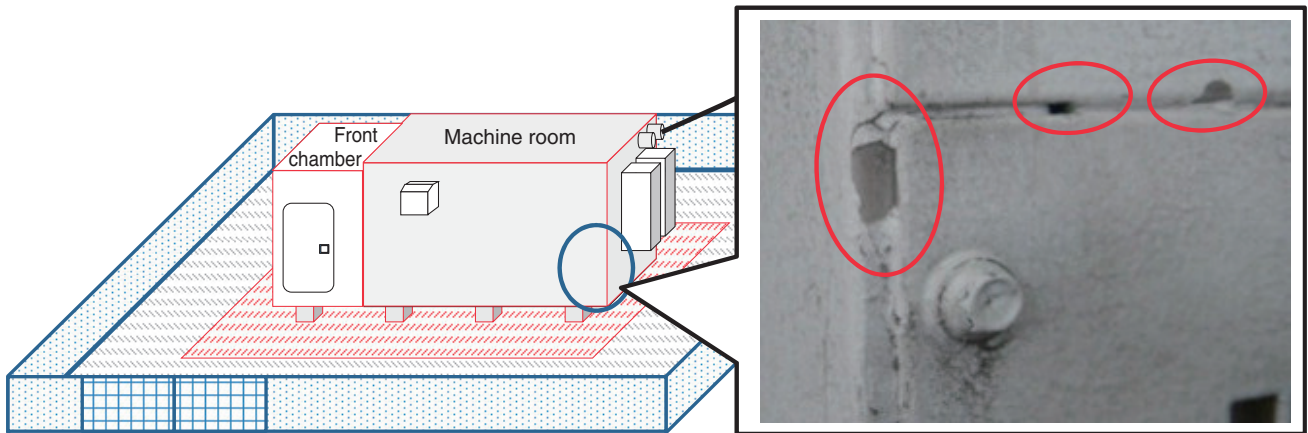
Fig. 3. Example of deterioration in RT-BOX paint.

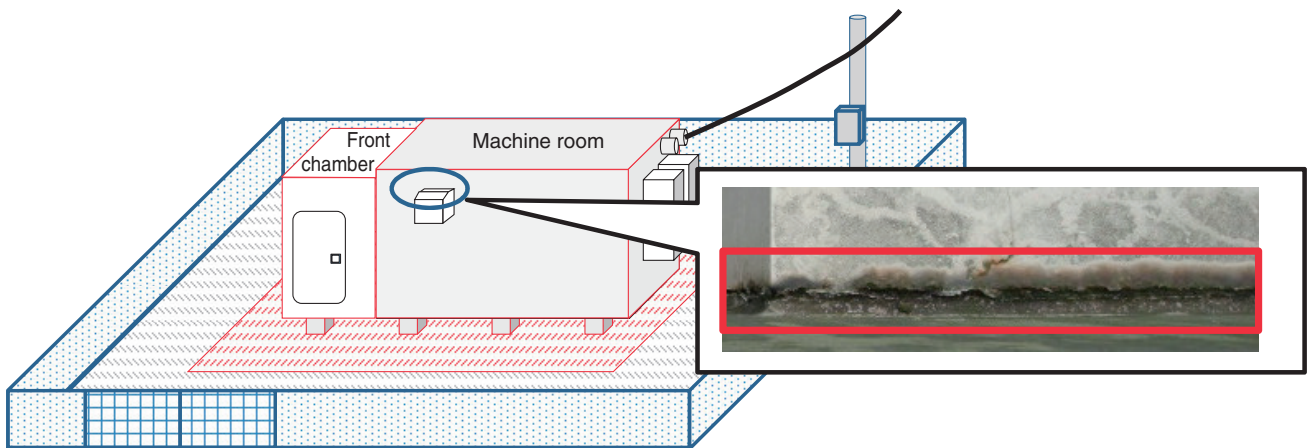
Fig. 4. Example of deterioration in caulking.

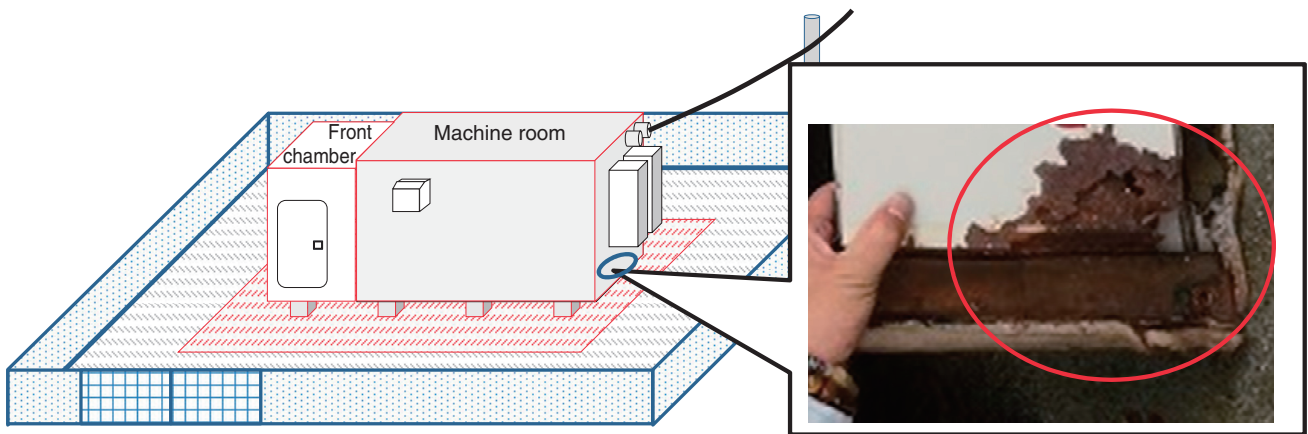
We can also show an example of deterioration caused specifically by the structure of the RT-BOX housing. Here, moisture generated by the outdoor unit of the air conditioning equipment in the RT-BOX turned into pooled water and was not appropriately discharged. This water then entered the housing from the seam between this outdoor unit and the outer wall,

and the interior portion of steel at the lower side of the RT-BOX corroded (Fig. 5).

Fig. 5. Example of deterioration of inner steel due to pooled water from RT-BOX air conditioning equipment.
