### Practical Field Information about Telecommunication Technologies

## A Case Study of Malfunction of Wireless Communication System Caused by Electromagnetic Disturbance at a Construction Site

### Technical Assistance and Support Center, NTT EAST

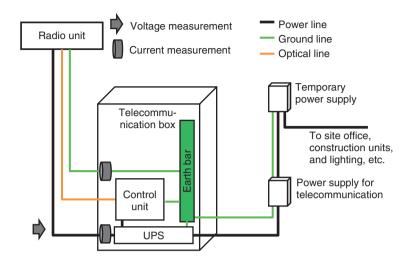
Fig. 1. Configuration of units and components composing wireless communication system.

The configuration of the wireless communication system is shown in **Fig. 1**. The wireless communication system has control and radio units. The control unit is located in a telecommunication box, and the radio unit is located outdoors. The radio unit has optical, power, and ground lines. Each line is connected to the control unit, uninterruptible power supply (UPS), and earth bar. The UPS is powered by a temporary power supply through the power supply for telecommunication. A temporary power supply also supplies power to the site office, various construction
