Case Studies in 50-bit/s Leased Lines: Modem Communication Failure at Earth-return Circuit and the Cause of Failure to Replace Metallic Transmission Line with Optical Cable

Technical Assistance and Support Center, NTT EAST

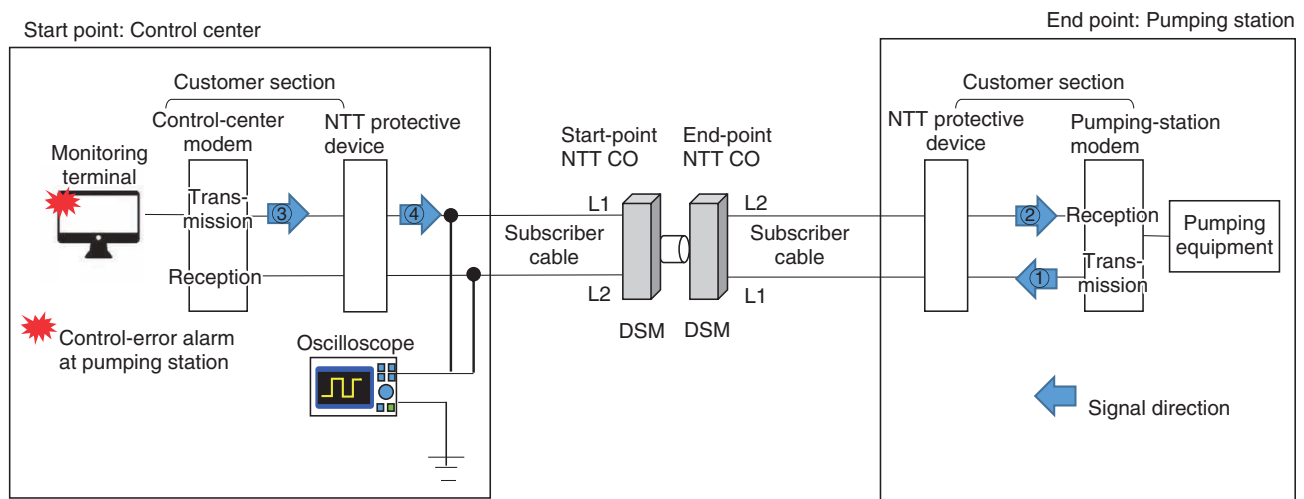
Fig. 1. Equipment and measurement configuration.

The configuration of the customer's system and NTT network (leased line) are shown in **Fig. 1**. To identify the cause of the failure, it is important to clarify the type of leased line. NTT generally provides two types of transmission methods for 50-bit/s leased lines: metallic return and earth return. A metallic-return method involves making a closed circuit with two wires in the line, and the direction of the current identifies the transmission and reception. An earth-return method involves making a closed circuit of a cable and ground (earth) with a unidirectional line used for transmission and the other for reception.

We assumed that the control-error alarm in the customer's equipment was caused by an error in the communication signal. We first decided to investigate the voltage and current waveform conditions of the transmission signal between the DSM and customer's equipment. We used an oscilloscope to measure the voltage and current of the modem signals, as shown in **Fig. 1**, at the control center and pumping station.

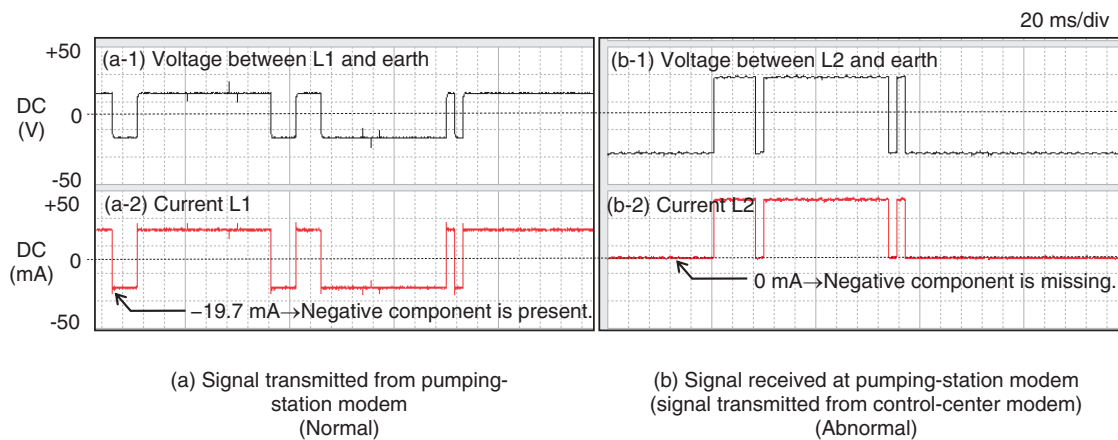
Fig. 2. Signal waveform measured at pumping station.

The measured waveform of the transmitted signal from the pumping-station modem (transmitted signal) and received signal from the control-center modem (received signal) are shown in **Figs. 2(a)** and **(b)**, respectively. The transmitted signal (**Fig. 1** Signal direction①) is formed using a bipolar encoding (i.e., 0 and 1 expressed as positive and negative) for both voltage and current (**Fig. 2(a-1, a-2)**); however, the received signal (**Fig. 1** Signal direction②) is formed using a unipolar encoding (0 and 1 expressed as positive and 0A) with the negative component missing (**Fig. 2(b-2)**).

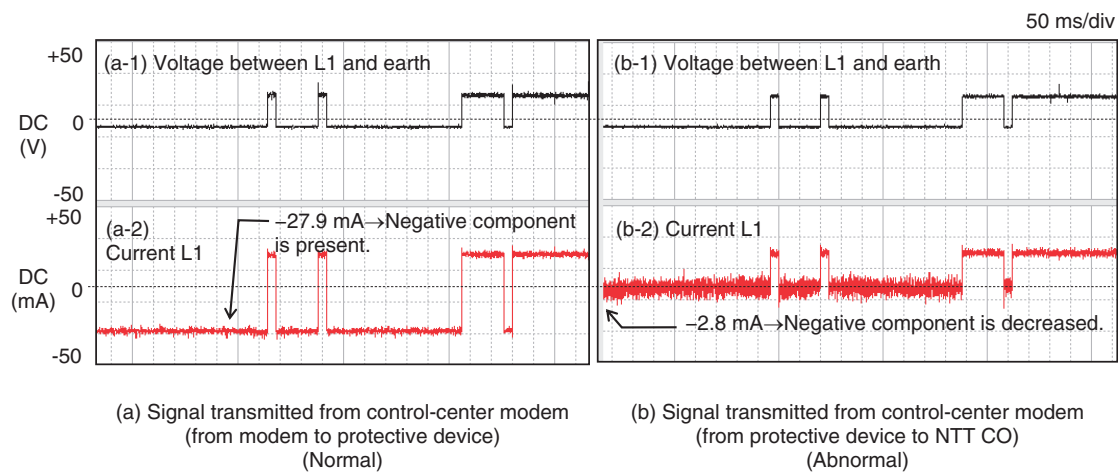
Fig. 3. Signal waveform measured at control center.

On the basis of these results, we concluded that the control-center modem was transmitting a normal bipolar encoding signal. However, before reaching the pumping-station modem, the transmitted current signal degraded to a unipolar encoding signal (**Fig. 3**). **(B) Electrical characteristics of subscriber-lines (copper-impairment test)**

Considering the results presented in sub-section (A), the control-error alarm was caused between the control-center modem to the NTT protective device; therefore, we measured the electrical characteristics, including the customer section (the customer modem to the NTT protective device) at the control center. From those measurement results, the insulation resistance between L1 and earth was nearly 0Ω ; in other words, L1 was in the earth-fault state within the customer section.

This case was not caused by NTT equipment failure but the customer's equipment. The customer's arrester installed in the customer section was broken, and L1 was connected to earth, which caused the signal transmitted from the control center to leak into earth. The pumping-station modem (on the receiving side) was thus unable to recognize that signal; therefore, the control-error alarm occurred at the control center.

were wired directly to bypass the other customer's equipment. Thus, the control-error alarm no longer occurred. As a result of the customer's equipment inspection of the private wiring section, it was confirmed that the customer's arrester (surge arrester) inserted in this section was defective.

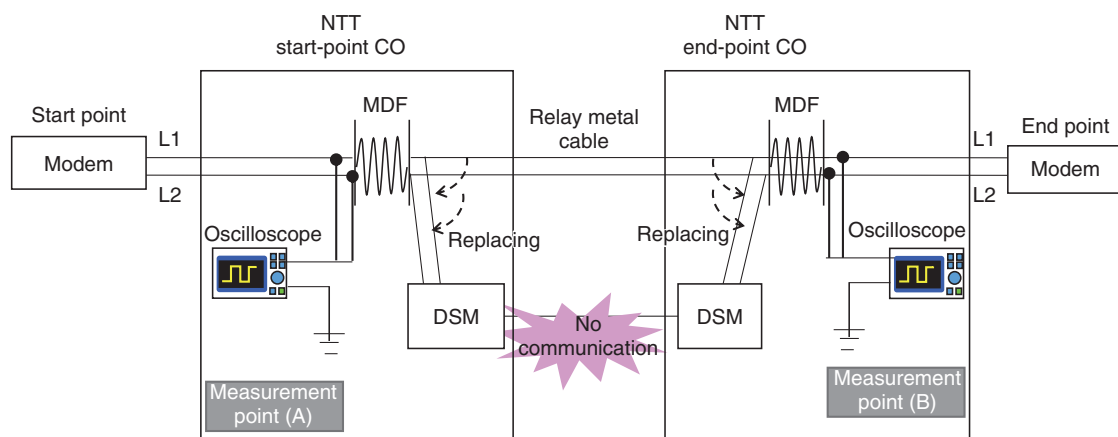
Fig. 4. Equipment configuration and failure that occurred.

There are various types of 50-bit/s leased line systems, as listed in **Table 1**, and different subscriber-line cards are used for each type. The results of an interview with the customer revealed that they were using an earth-return/unidirectional communication system for their terminals, so the NTT local service center member selected the VT1 package as the line

card and replaced the line. However, a communication failure occurred. Thus, TASC was asked to investigate the cause of the failure. The configuration of the equipment involved in this case study is shown in **Fig. 4**.

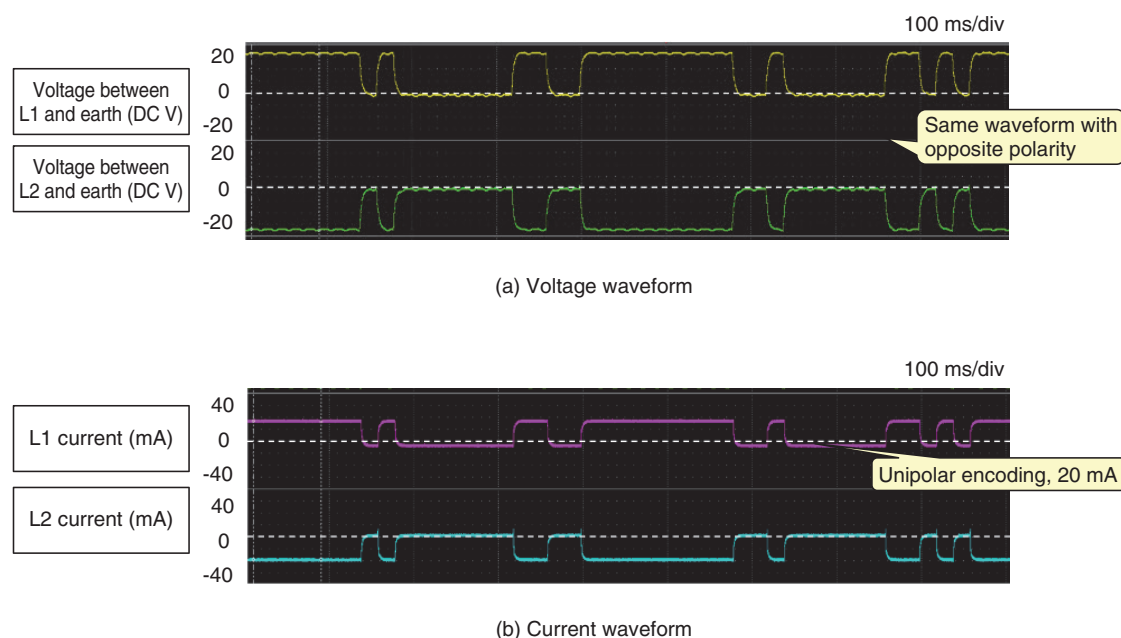
Fig. 5. Measurement results.

The measurement results are shown in Fig. 5. The voltage waveforms on L1 and L2 had opposite polarity (Fig. 5(a)), indicating that the modems use the metallic-return system. Moreover, the code polarity of both voltage and current did not change, indicating that the encoding scheme is a unipolar encoding with a current of 20 mA (Fig. 5(b)).

Considering the above results, we concluded that the customer's 50-bit/s leased line differs from that stated in the information initially provided by the customer; the line uses a unidirectional 2-wire unipolar metallic-return system with a transmitting terminal having a power source. The VT2 or VT3 package should be used for this system, and operation modes

On the basis of the above findings, communication failure was resolved when C1 and C2 selected the subscriber-line VT3 package. Since the metallic transmission line could be replaced with an optical cable, the metallic cable between the start-point and end-point COs could be eliminated.
