# Practical Field Information about Telecommunication Technologies

# Damage to Plastic Components Caused by Solvent Cracking

This article introduces two case studies of damage to plastic components caused by solvent cracking and the countermeasures developed by NTT EAST. It is the ninth in a bimonthly series on the theme of practical field information about telecommunication technologies. This month's contribution is from the Materials Engineering Group, Technical Assistance and Support Center, Maintenance and Service Operations Department, Network Business Headquarters.

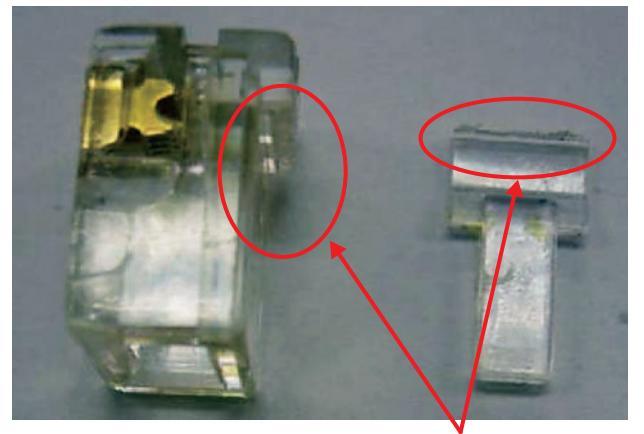
Fig. 1. Modular plug with damaged latching tab.

At a certain metalworking plant in Japan, the modular plug of the helical cord of a particular telephone receiver had to be replaced repeatedly because the plug's latching tab broke away from its base three times over the course of a five-year period (**Fig. 1**). The telephone set sat on a desk on the work floor and traces of cutting oil used for cutting metal plates on a lathe could be seen splattered about the desk. Grease from this cutting oil was also found on the telephone's helical cord (**Fig. 2**). The damaged modular plug was

Location of break

In this case study, the plug's acrylic resin had low resistance to solvent cracking and cutting oil was found on the plug, so two of the key conditions for crack generation were present.

Connecting a modular plug to the modular socket on a receiver that has been splashed with cutting oil may cause the plug's tab to eventually break away owing to ongoing damage caused by remnant oil. Therefore, the socket should be wiped clean of remnant grease with a cotton swab or other implement before the plug is inserted. We also recommend using a gel to fill the gap in the plug's aperture where the spiral cord is inserted to prevent cutting oil from entering the socket.

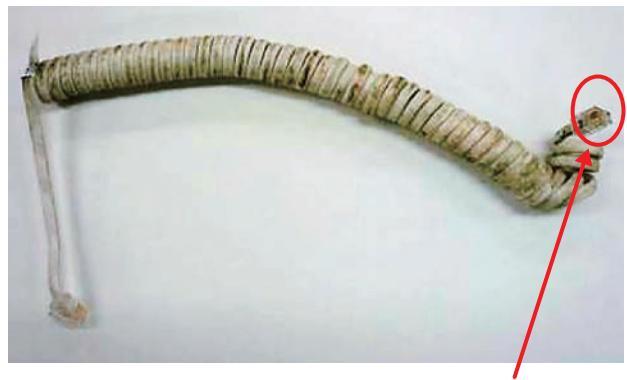
Fig. 2. Helical cord stained with grease from cutting oil.

Broken modular plug

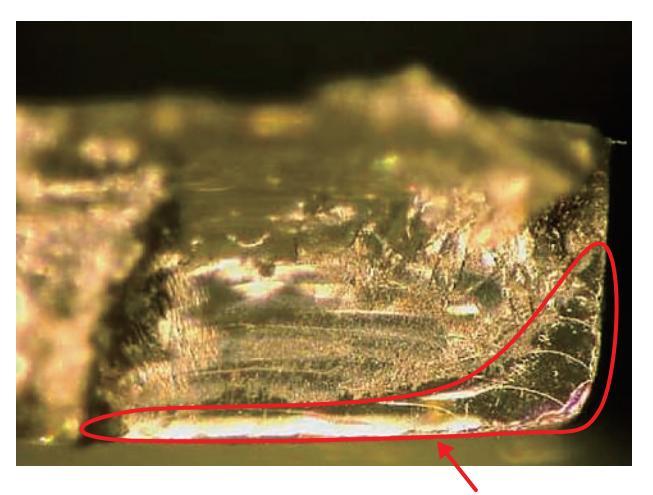
Fig. 3. Fractured surface of modular plug damaged at metalworking plant.

The fractured surface of the damaged plug was observed with a digital microscope and found to be highly glossy and mirror-like without any unevenness (**Fig. 3**), which is a characteristic feature of solvent cracking.

Mirror-like fractured surface

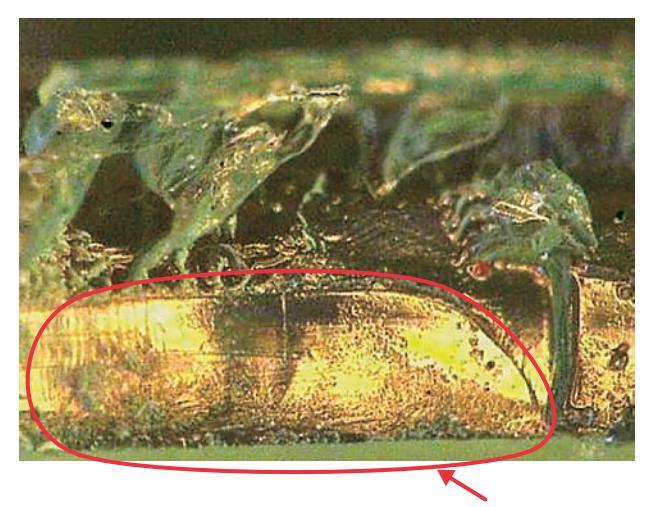
Fig. 4. Experimentally reproduced fractured surface.

To continue our investigation, we conducted an experiment to reproduce such solvent cracking using the same type of cutting oil as used at the metalworking plant. When the receiver of a telephone set is lifted off its hook, the cord is stretched, which applies stress to the latching tab, which pushes it away from its base. To simulate this process, we coated the latching tab of a new modular plug with cutting oil, applied stress to the tab's base, and heated the tab at 80°C using a Geer oven to accelerate the reaction. After two weeks, cracks occurred at the base. Digital microscope observation of the fractured surface revealed a smooth, mirror-like surface similar to the fractured surface of the actual damaged tab at the metalworking plant (**Fig. 4**).

Mirror-like fractured surface

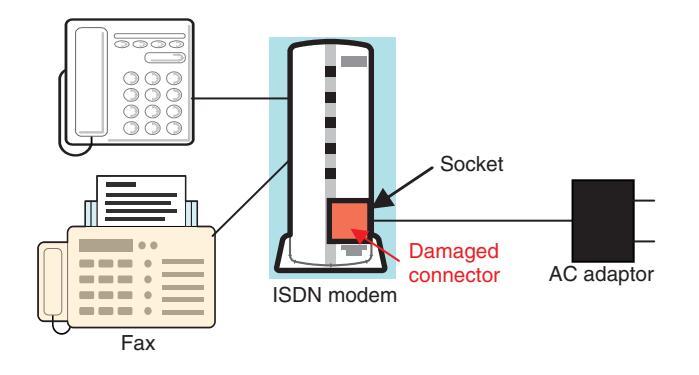
Fig. 5. Location of damaged connector.

In response to a fault report stating that power could not be supplied to an ISDN (integrated services digital network) modem, an inspection found that the connector of the modem's AC adaptor was damaged (**Fig. 5**). Further inspection also found the remains of ants in the socket-pin area and on the nearby circuit board, as shown in **Fig. 6**. There had been no reports

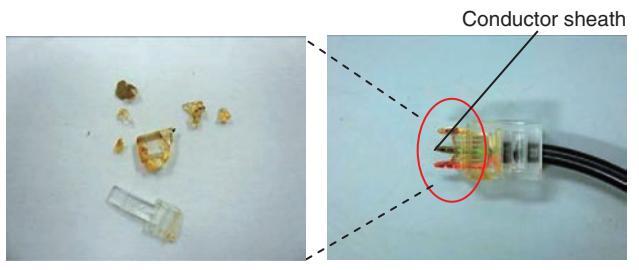
Fig. 7. Damaged AC-adaptor connector.

Damaged pieces of connector Full view of damaged connector

The connector (made of polycarbonate material) was found to have fallen to pieces, exposing the sheathing of its conducting wires (**Fig. 7**). Moreover, the sheathing (made of flexible polyvinyl chloride) was also found to have surface sores (**Fig. 8**). A brownish adherent thought to be the remains of ants

We analyzed the brownish adherent in the damaged connector by ion chromatography and found the presence of formic acid (HCOO<sup>-</sup>), as indicated in **Table 1**. While connector damage due to formic acid was therefore suspect, microscopic observation of the connector at the breaks revealed smooth, mirror-like fractured surfaces. We therefore investigated the possibility that solvent cracking was the cause of this damage. The abovementioned charred ant remains found on the circuit board near the socket led us to believe that an ant had entered through gaps in the modem's enclosure and made contact with metal pins causing an electrical short and consequently generating high temperatures. Furthermore, taking into account the presence of sores on conductor sheaths near that circuit board, we considered that those sheaths were also heated when the electrical circuit shorted. We therefore surmised that the heating of conductor sheaths in this way could cause plasticizing agent to separate from the sheath and come into contact with the polycarbonate connector, thereby generating solvent cracking. Infrared reflection spectroscopic measurements of these conductor sheaths confirmed the presence of a phthalate ester plasticizer. The penetration of phthalate ester plasticizer into polycarbonate resin is known to facilitate solvent cracking. We therefore concluded that solvent cracking was probably the reason for the damage to the AC-adaptor connector in this case study.

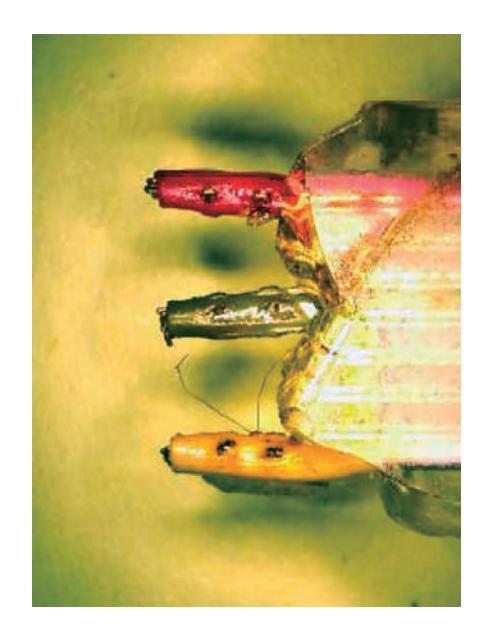
- Fig. 8. Sores on conductor sheaths inside connector.
- Table 1. Results of ion chromatography analysis of substance in damaged connector.
