Measurement Results for Lightning Surge Current on AC Mains Line Connected to Access Network Equipment

Tetsuya Tominaga[†], Jun Kato, Kazuo Murakawa, and Hiroshi Yamane

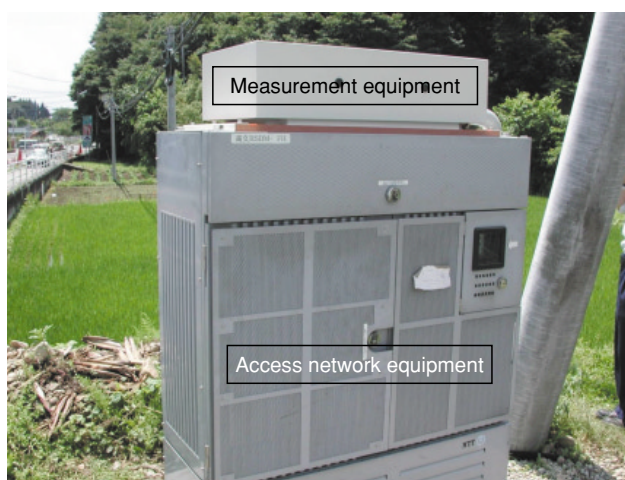
Fig. 1. Access network equipment.

The access network equipment that we tested and the measurement system are shown in **Fig. 1**. The access equipment is located outdoors and is directly fed by an ac power mains line. The measurement system is also connected to the ac power mains line through an isolation transformer. The access equipment has power units and telecommunication units.

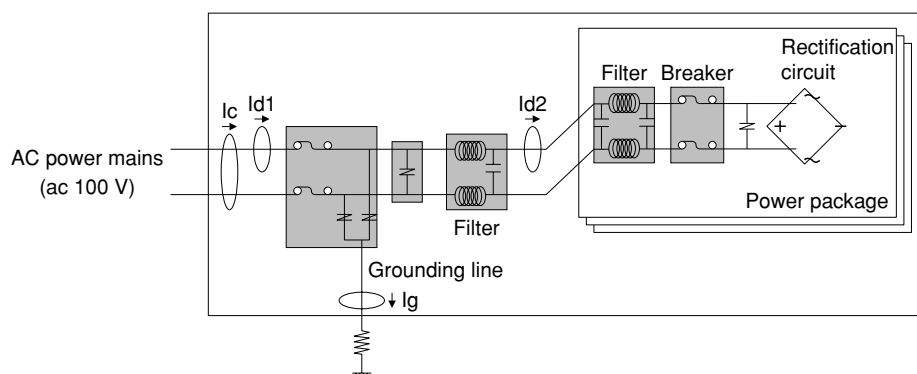
Fig. 2. Schematic composition of power unit and measurement points.

The configuration of a power unit is schematically shown in **Fig. 2**. Electromagnetic compatibility (EMC) mitigation devices are attached to the power unit, for example, a filter for protecting against radio waves and switching noise and devices for protecting against lightning, as shown in Fig. 2. An overcurrent breaker (rated current: 4 A) is also attached to protect against short-circuits and overload and for safety reasons. To clarify the mechanisms of unnecessary breaker tripping, we measured lightning currents on

the ac mains lines and the grounding line. The measurement points, which are shown in Fig. 2, were as follows:

- Ig: Grounding line current
- Ic: Common mode current
- Id1: Power line current
- Id2: Power line current between ac power mains and package lines

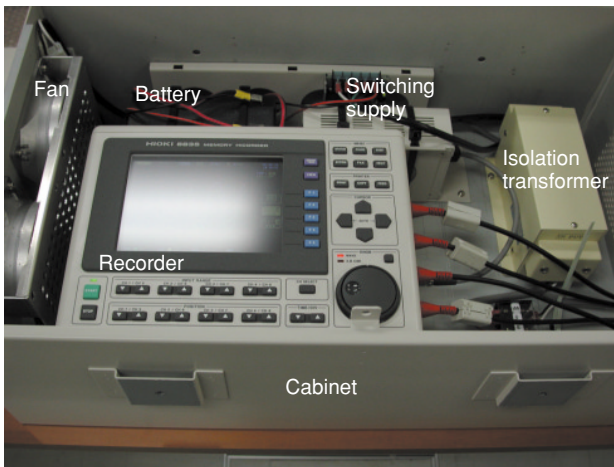
Fig. 3. Measurement system.

The measurement system (**Fig. 3**) was composed of a waveform recorder, an isolation transformer, an ac power mains, a battery, fans, and a metal enclosure. The recorder was a HIOKI 8835 oscilloscope with four channels for wave shape measurement. The sampling interval was set to 1 μ s. The waveform recorder shared the ac power mains for the access equipment. The isolation transformer isolated both the measurement system and the access equipment, and its impedance in the lightning surge frequency band was high enough to not influence the lightning surge current flowing into the access equipment.

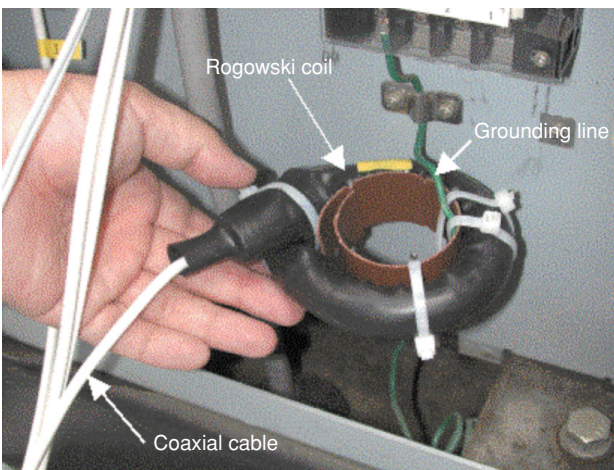
Fig. 4(a). Appearance of Rogowski coil.

To measure lightning surge currents, we used four Rogowski coils (**Fig. 4**). Figure 4(a) shows the Rogowski coil and Fig. 4(b) shows its equivalent circuit. The Rogowski coil does not have current saturation properties, so it is useful for measuring high currents such as lightning surges. Moreover, it exhibits time derivative properties, so an integral circuit was attached to the coil as shown in Fig. 4(b). As shown in **Fig. 5**, the Rogowski coil covers a sufficiently wide frequency range for lightning surge current measurement, and its frequency band is from about 0.1 to 100 kHz.

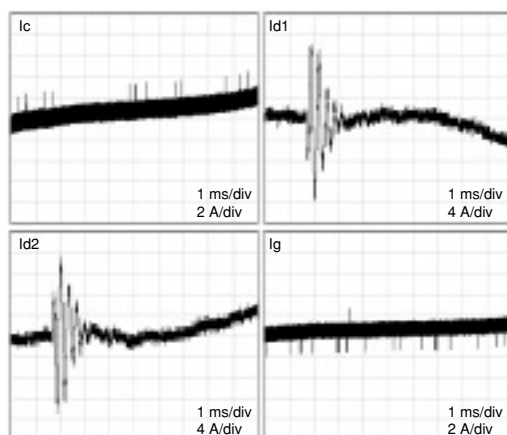
Fig. 6. Typical examples of damped oscillation waveforms.

In Fig. 6, currents I_{d1} and I_{d2} were obviously measured and they exhibited a normal mode current*¹ rather than a common mode current*¹. The peak cur-

rent was about 20 A peak-to-peak. The currents flowed between ac mains lines. The Id2 current may have flowed into the overcurrent breaker. Figure 7 shows an example of a triangular waveform that can be recognized as a lightning surge current. The lightning surge currents flowed through the ac mains and ground lines, respectively. The peak level of the Id2 current was about 500 A peak-to-peak.

According to the measurement results, there were several types of current flows as shown in Figs. 6 and 7, for example, from line to ground, line to line, and combinations of these. There were also many waveforms longer than 0.3 ms, which is much longer than the 8/20 μ s current wave shape (front time*2 is 8 μ s and time to half value*2 20 μ s), and there was clear evidence of normal mode currents (Id1 and Id2), which can cause malfunctions in the power unit's overcurrent breaker.

The main frequency of damped oscillation waves, such as those in Fig. 6, was evaluated. The results are shown in Fig. 9, where the horizontal axis is frequency and the vertical axis is the number of damped waveforms. The average damped oscillation frequency was about 6.4 kHz and the maximum frequency obtained was about 60 kHz. The percentage of damped current was up to about 74% in all measured data. Therefore, it may be necessary to include damped currents as well as triangular waveforms in the surge immunity test.

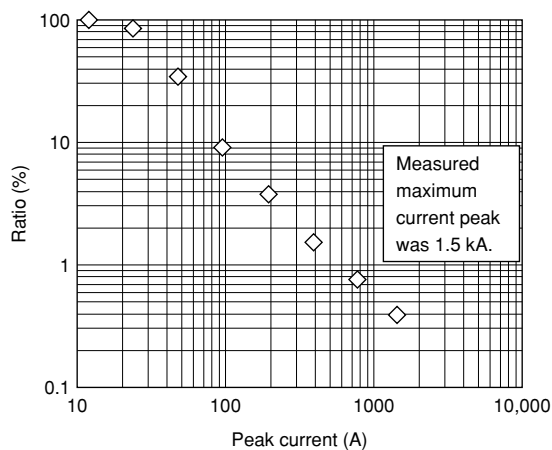
Fig. 8. Accumulation ratio of current peak levels Id2.

The waveform parameters for current Id2 (accumulation ratio of the peak current, damped frequency, wave front time, and wave time to half value) are shown in Figs. 8, 9, 10, and 11. The accumulation rate of the peak value of the lightning surge current is shown in Fig. 8. The measured maximum current peak was 1.5 kA and the average value was 30 A. We found that the accumulation ratio above 100 A was about 10%, while that above 1 kA was about 1%. Therefore, small peak surge currents frequently entered the power unit and the breaker. The current

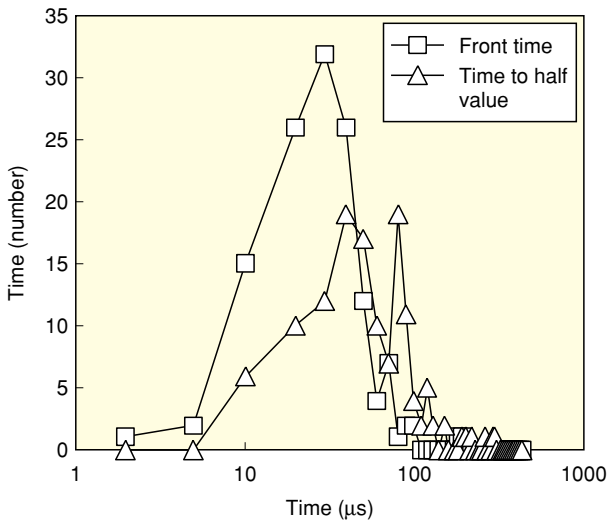
Fig. 10. Front times and times to half value.

Figure 10 shows the front times and times to half value of measured waveforms. When a waveform is a damped oscillation waveform, the front time is the value of the rise time from zero to the peak, and wave time to half-value is the time from the peak to half the peak height. In Fig. 10, the average wave front time is 32 μs and the average wave time to half value is 64 μs. There are several wave shapes with a time to half value of more than 0.3 ms, and the 50% cumulative occurrence rate value of the time to half value is about 100 μs. In other words, over 50% of the measured lightning surge half-time values were five times longer than the combination wave current shape (half time value is 20 μs) defined in ITU-T K.44 for the ac mains test. Because the power in our experiment was higher, we found that longer waveforms tripped the circuit breaker rather than shorter ones. During the measurement, the breaker-tripped malfunctions occurred at the same time that a longer surge current was measured. Therefore, longer waveforms, such as

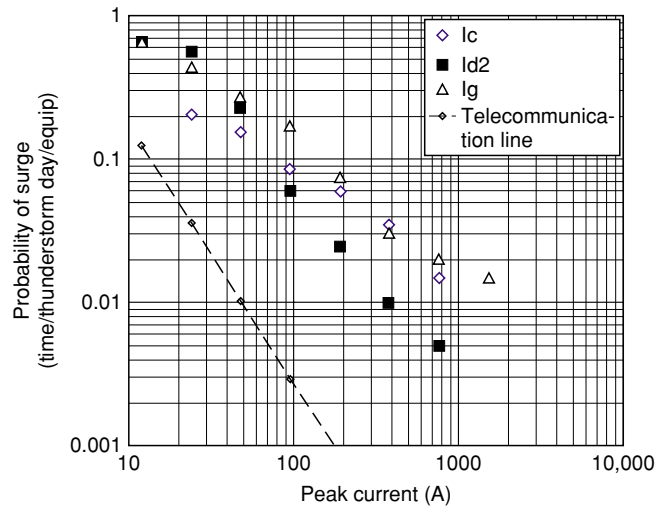
Fig. 11. Accumulated probability of surge current.

Figure 11 shows the accumulated probability rate of the peak current for Ic, Id2, and Ig. In Fig. 11, measured data related to telecommunication lines is also shown. The current levels for Ig are higher than other currents.

The probability ratio of currents shown in Fig. 11 can be approximated as

$$p = kI^{-x}, \tag{1}$$

where I is the current level, p is the probability of a lightning surge per thunderstorm day, and k and x are coefficients of the approximation equation. For the current flow from a telecommunication line to ground, k is 11 and x is 1.8; for the current flow from a power line to ground (Ic), we estimated $k=15$ and $x=1.1$. Comparing the current flow from a telecommunication line to ground with that from a power line to ground, the probability of a 100-A lightning surge current was about 20 times greater in the latter case. The average of thunderstorm days per year in Japan is from 20 to 40 days, so the probability of a 100-A lightning surge current is 0.1 in Fig. 11. Therefore, a 100-A lightning surge current flows into the access network equipment two to four times per year and a lightning surge current of up to 300 A flows into it once per year.

The current flowing in common mode was from two to five times larger than that in normal mode in the range of 100 A or more, but we think this difference is not so big. Therefore, in a lightning surge test it is necessary to consider the surge current flowing into the power unit from one power line conductor to
