## Technology for Assessing Optical Cable Reliability after a Disaster

In disasters accompanied by major ground movement, such as the 2004 Niigata Chuetsu Earthquake, the reliability of telecommunications equipment with no perceptible damage should be assessed in parallel with the restoration of stricken facilities. This report introduces technology for assessing the reliability of optical cables after such a disaster.

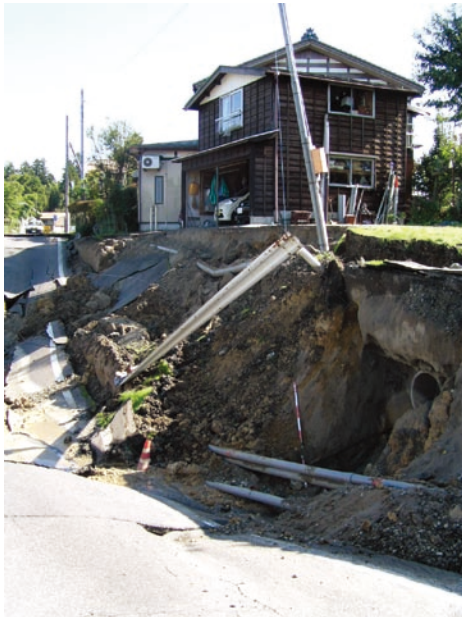
Fig. 1. Exposed conduits in a collapsed road.

The Niigata Chuetsu Earthquake, which occurred on October 23, 2004, caused much damage to the social infrastructure, including great damage to telecommunication facilities, as shown in **Figs. 1** and **2**. This included damage to optical trunk line cables, the backbone for medium- and long-distance communications, with breaks occurring at ten locations due to landslides and avalanches. At these locations, facilities were restored relatively quickly thanks to the efforts of maintenance engineers. Nevertheless, the restoration of services was no guarantee that these cables would not experience problems in the future. More than 300 km of optical trunk line cables were deployed in the stricken area, and most of them were underground cables, so there was no easy way to check them for damage from their external appearance. It was therefore decided to measure residual elongation strain and bending loss in the optical fibers remotely from an NTT central office as an efficient method for determining disaster-related damage in optical cable.

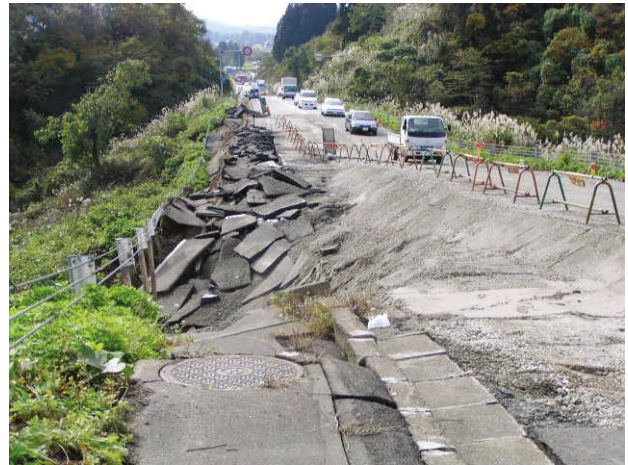
Fig. 2. Damaged manhole.
