Sulfur Damage and Its Countermeasures in Telecommunication Equipment and Facilities

Technical Assistance and Support Center, NTT EAST

This article introduces cases of corrosion caused by hydrogen sulfide in telecommunication equipment and facilities and countermeasures against it. This is the sixty-fourth article in a series on telecommunication technologies.

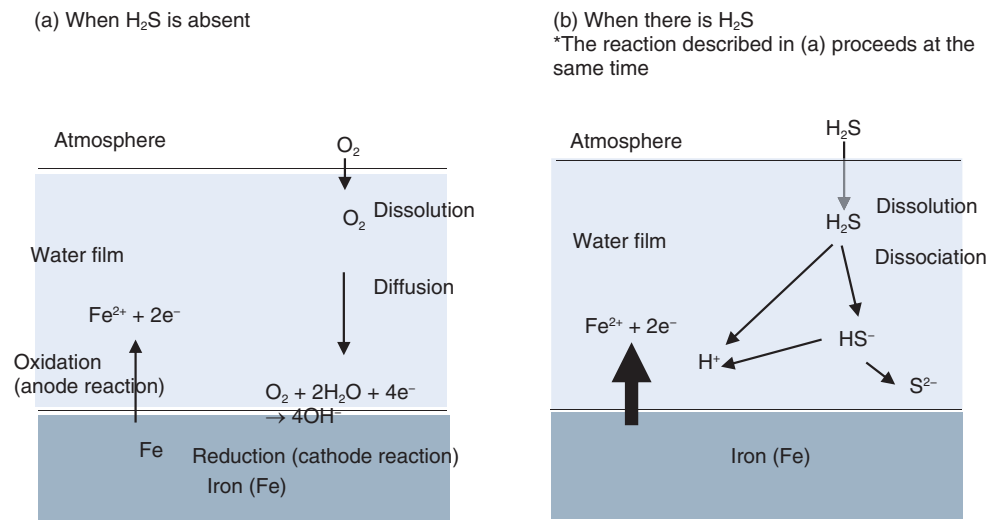
The corrosion reaction that causes sulfur damage occurs when a water film is formed on the surface of a material by condensation or moisture adsorption. As shown in **Fig. 2(a)**, when H_2S is absent, the corrosion of iron is caused by oxygen in the atmosphere dissolving in the water film, followed by reduction of the dissolved oxygen on the surface of the iron and simultaneous dissolution of the iron. When sea salt is also dissolved in the water film, the corrosion rate of iron will increase due to the increased electrical conductivity of the water film. When there is H_2S present

Fig. 2. Corrosion mechanism.

(Fig. 2(b)) in addition to the reactions illustrated in Fig. 2(a), the H₂S dissolves and dissociates in the water film to produce H⁺ ions, which results in an acidic environment in the water film. This acidity accelerates the dissolution of iron and results in a high corrosion rate.

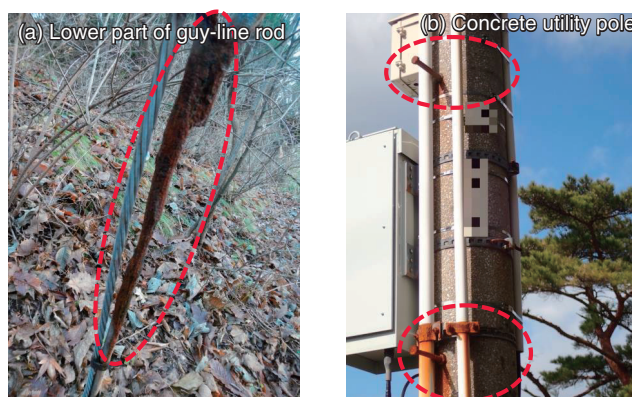
Examples of sulfur damage to outdoor facilities at a hot-spring area are shown in Fig. 3. Significant rusting (reddish brown) was found on the metal bands at

the lower part of the guy-line rod and scaffolding bolts on the utility pole. Thinning can be seen in the central part of the guy-line rod, so the rod may break when corrosion progresses. Although this type of corrosion can be caused by either salt or sulfur damage, since this hot-spring area is located in a mountainous area far from the coast, the effect of salt damage is considered small. Moreover, measurements of gas concentration at the locations shown in Figs. 3(a) and (b) detected H₂S at 1.5 ppm (parts per million) and 0.9 ppm, respectively. The above corrosion phenomena are thus considered to be sulfur damage, the main

Fig. 3. Examples of sulfur damage to outdoor facilities.

factor of which is H_2S . The regulation value for atmospheric concentration of H_2S stipulated by the Offensive Odor Control Law is 0.06 to 0.2 ppm [1], and the Industrial Safety and Health Act stipulates that the concentration of H_2S should be less than 1 ppm to ensure a safe working environment [2]. Accordingly, the measured H_2S concentrations (1.5 and 0.9 ppm) at these facilities indicate that H_2S exists at high concentrations at those locations.

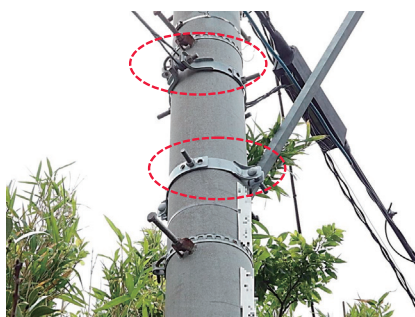
Fig. 5. Example countermeasure against sulfur damage to outdoor telecommunication facilities (metal bands with powder coating).

Since concentration of H_2S is higher outdoors than indoors, namely, at the ppm level, countermeasures are required to provide higher corrosion protection performance. To meet this requirement, it is necessary to ensure that outdoor facilities and equipment are prevented from coming into contact with H_2S . One way to prevent contact is to coat the surface of the base metal with a paint that has stronger adhesion. By increasing the adhesion between the paint coating and base metal, it is possible to suppress (i) direct contact between H_2S and the metal and (ii) the adhesion of moisture (water film) containing H_2S to the metal. Therefore, it is possible to reduce the occurrence of sulfur damage. An example of metal bands coated with a powder coating, which has stronger adhesion and higher corrosion resistance than conventional coatings, attached to a concrete utility pole is shown in **Fig. 5**.

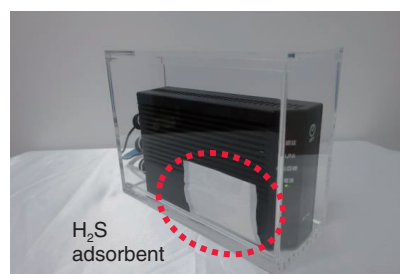
Fig. 6. Countermeasure against sulfur damage to indoor telecommunication equipment.

An example of a countermeasure against sulfur damage to indoor telecommunication equipment is shown in **Fig. 6**. The concentration of H_2S can be reduced by installing the terminal equipment inside a sealable acrylic box and placing H_2S adsorbent inside. In fact, a customer who had been experiencing failures of terminal equipment every two months or

so has been free of failures for more than 10 months after starting to use an acrylic box.
