Impact of Wildlife on Access Network Facilities—Problems Caused by Monkeys and Countermeasures against Them

Technical Assistance and Support Center, NTT EAST

Telecommunication network facilities are exposed to a variety of indoor and outdoor environments in which they can be affected by the activities of wildlife. This article introduces problems caused by monkeys on access network facilities and countermeasures against these problems. This is the sixty-eighth article in a series on telecommunication technologies.

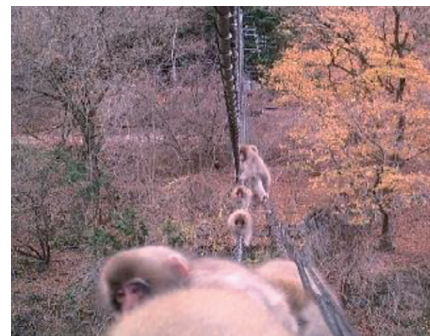
Fig. 3. Monkeys crossing cables.

To investigate the cause of the problem, we set up a fixed-point camera at the site to monitor the cable status for approximately a month. From the captured video, we observed more than a dozen monkeys per day crossing the cable in the incident section. Although the monkeys did not deliberately unbundle the cable, they strongly grabbed the cable for running and sometimes pulled the cable when losing their balance (Fig. 3).

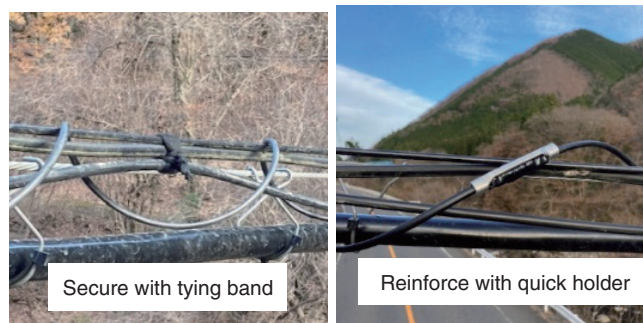
(a) Securing a cable

(b) Reinforcing SH

Fig. 5. Countermeasures against cables sagging.

- (1) The CCH was replaced with a spiral hanger (SH), which is mainly used in high-wind areas, and the cable was secured to the suspension wire with tying bands (Fig. 5(a)).
- (2) To prevent the SH from falling, “quick holders,” which are fixtures that prevent damage to the connectors of the SH and stop them from dislodging, were installed (Fig. 5(b)).

After these countermeasures were implemented, cable sagging did not recur. We thus believe that similar countermeasures will be effective at other locations in similar environments.

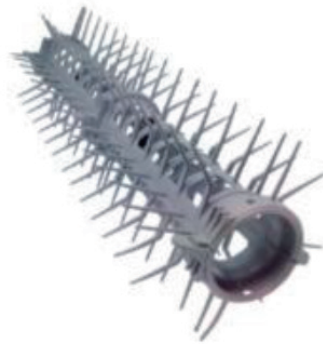
Fig. 6. Bird-damage-prevention device

We devised a countermeasure using a commercially available bird-damage-prevention device to make it harder for monkeys to cross the cable (Fig. 6). This device has a spiked surface for preventing birds from perching on cables, and when attached to the cable, it rotates and makes it difficult for a monkey to grab the cable.

We installed the device on an optical fiber cable deployed in high monkey traffic area. Initially, the device was effective in preventing monkeys from crossing the cable. However, we found that monkeys have very high motor skills, i.e., can leap two to three meters horizontally and have an excellent sense of balance, so they can easily avoid the device and cross the cable, even from a precarious position. After
