## Water Penetration Inspection Methods for Remote Terminal Boxes

This article describes the problem of water entering remote terminal boxes and corresponding inspection methods.

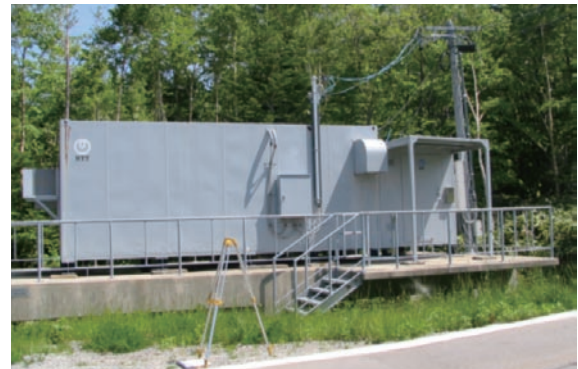
There have been reports of rain water seeping into remote terminal (RT) boxes (**Fig. 1**) through inferior caulking or caulking cracks at joints between the housing and air conditioning equipment and through cable conduits. Water entering RT boxes can cause insulation faults in telecommunications equipment and accidents like collapsing floors, so checking for water penetration during inspections is an important aspect of RT-box maintenance. The water penetration inspection procedure is described in section 2.

Fig. 1. External view of RT box.
