## Case Studies of Failures of Business Phones Connected to VoIP Gateway

This article introduces case studies of failures of business phones connected to a VoIP (voice over Internet protocol) gateway developed by NTT EAST. It is the seventh in a bimonthly series on the theme of practical field information about telecommunication technologies. This month's contribution is from the Network Interface Engineering Group, Technical Assistance and Support Center, Maintenance and Service Operations Department, Network Business Headquarters.

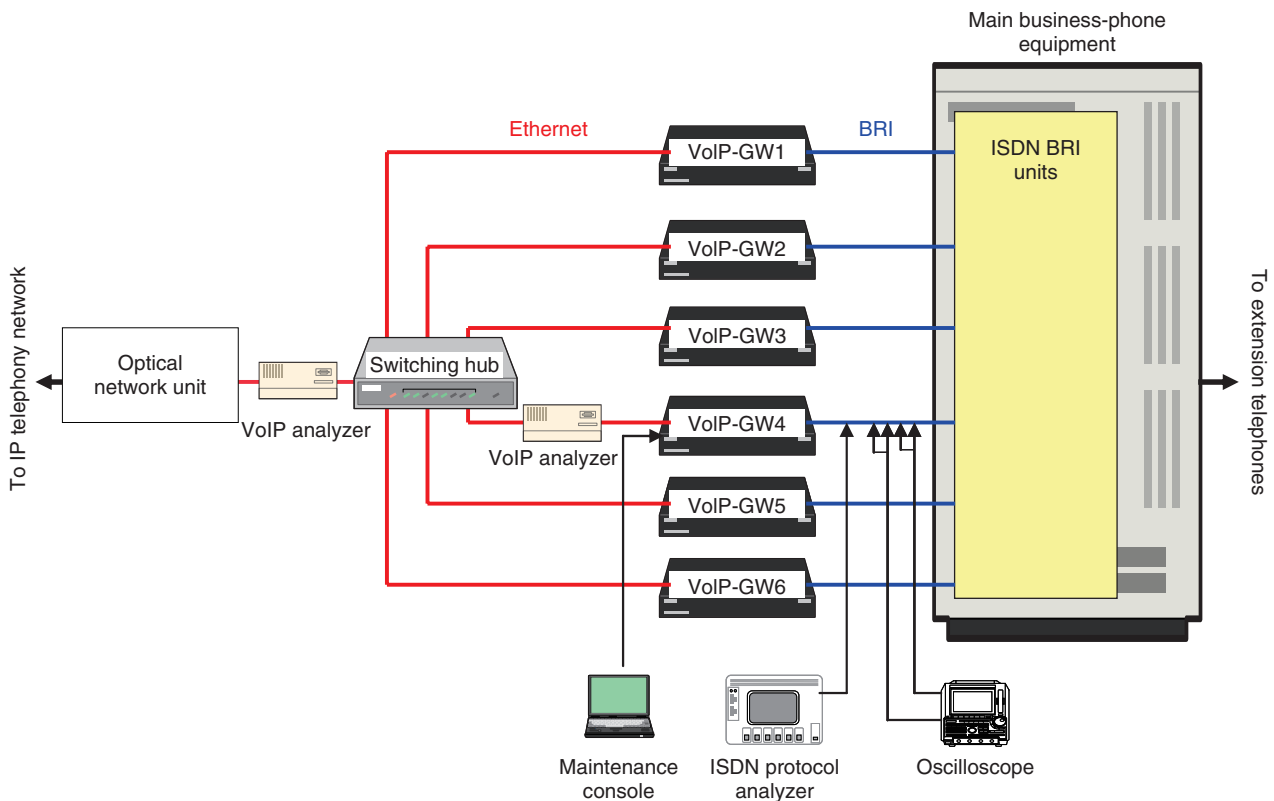
Fig. 1. Equipment configuration.

In this example, the customer was using NTT EAST's Hikari Denwa Business Type IP telephony service and had six VoIP-GWs connected to existing business phones. The VoIP-GWs were connected to

ISDN basic rate interface (BRI) units in the main business phone unit since the customer had been using NTT EAST's INS-Net 64 service\* before the IP telephony service. The equipment configuration is shown in **Fig. 1**.

The VoIP-GW failure log revealed that a “layer 1 down” event occurred many times on the BRI circuit between the VoIP-GW and main business-phone equipment. An excerpt from the log at the time that a failure occurred is shown in **Fig. 2**. Protocol monitoring using the ISDN protocol analyzer revealed “INFO lost” indicating “layer 1 down” in the same time period as the timestamps of the failures recorded in the VoIP-GW failure log. Signal monitoring between the VoIP-GW and main business-phone equipment revealed signal distortion and signal-suspended states in the signal waveform of the TA-TB line for transmissions from the main business-phone equipment to the VoIP-GW (**Fig. 3**). At this time, no changes in conduction noise in the commercial power supply or telecommunication lines were detected. Analysis of captured packed data revealed no packets or sequences that could be considered abnormal.

This failure was considered to occur for the following reason. Owing to the distortion and suspended

The ISDN BRI unit connected to the business phone was replaced. This restored the line to normal operation.

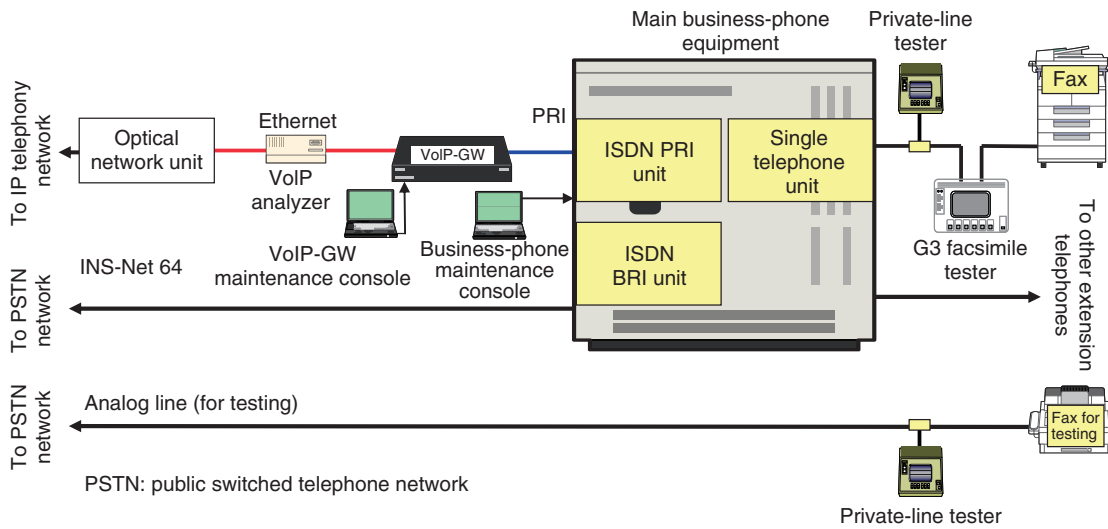
Fig. 5. Equipment configuration.

In this example, a customer was using NTT EAST’s Hikari Denwa Business Type IP telephony service. The business phones were connected to a single VoIP-GW via the main business phone equipment. They were also connected to INS-Net 64 as a backup circuit. The main business phone equipment contained an ISDN primary rate interface (PRI) unit connected to the VoIP-GW to accommodate the IP telephony service; an ISDN BRI unit to connect to

INS-Net 64; and a single telephone unit, which connected to a fax machine acting as an extension business-phone terminal. The equipment configuration is shown in Fig. 5.

This failure was considered to occur because of a mismatch in the setting covering the synchronization clock between the VoIP-GW and the main business phone unit, which led to unstable synchronization between them and degraded the transmission quality and generated defects in the fax communications.

The VoIP-GW synchronization setting was changed from slave to master so that the clock would be self-generated. This prevented this failure from reoccurring.

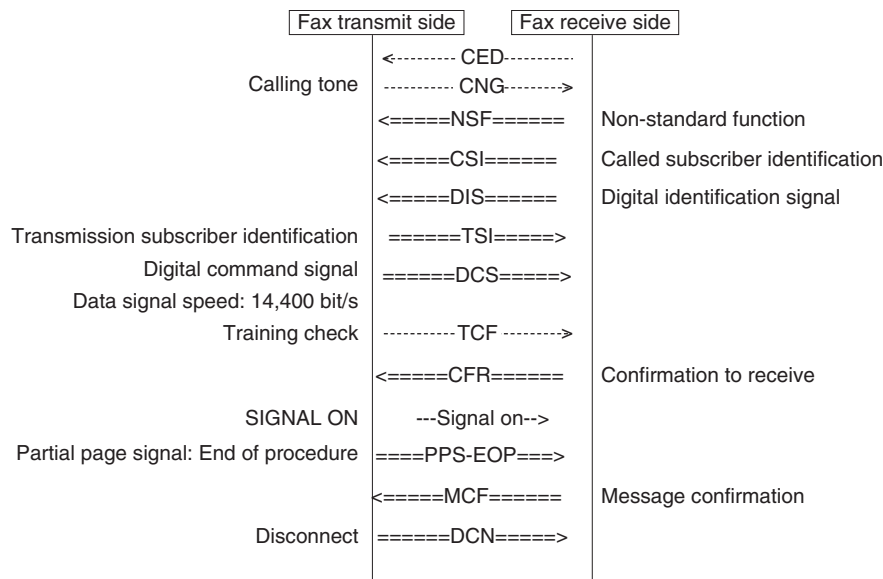
Fig. 8. Fax communication sequence during normal operation.

Monitoring of the fax communication sequence by the G3 facsimile tester revealed “failure to train”

signals, “frame anomaly” signals, and drop-in-transmission-speed sequences not observed during normal operation. The fax communication sequences at the time of failure and during normal operation are shown in **Figs. 7** and **8**, respectively. Bit-error measurements revealed a bit error rate of about 4–5% (effective number of bits:  $10^6$  in both the uplink and downlink). An analysis of captured packed data revealed no packets or sequences that could be considered abnormal. Data settings in the VoIP-GW’s ISDN interface indicated that the synchronization clock was set to slave, meaning that the clock was extracted from other equipment.
