Lightning Damage and Mitigation in Telecommunication Access Installations

Keywords: countermeasures, lightning damage, telecommunication access installations

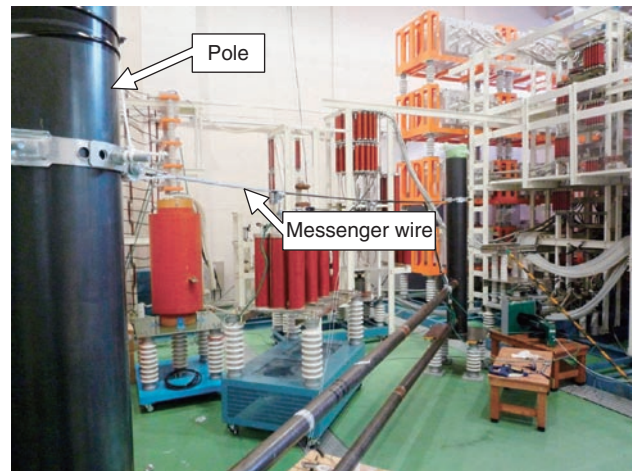
Fig. 5. Configuration of experimental installation.

We verified the damage mechanism of the messenger wire by applying lightning-surge current simulating a direct lightning strike to the messenger wire and then evaluated the result [1]. The configuration of the experimental facility is shown in **Fig. 5**. The messenger wire in this figure is made of high-corrosion-resistance steel (18CR) with a diameter of approximately 5 mm. The lightning surge is applied by an impulse generator (IG). The output and return terminal of the IG are respectively connected to the twined grip and the messenger wire via a ground wire. A 10/350- μ s current waveform regulated as a direct lightning strike was used in accordance with
