## Simple Tool for Inspecting Cleaved Optical Fiber Ends and Optical Fiber Connector End Surfaces

This article introduces a tool for inspecting cleaved fiber ends and connector end surfaces. The tool's main components are a microscope, cell phone, and special holders for the fiber or connector being inspected. It does not require focal adjustment and it can be used to inspect and clearly distinguish whether a fiber has been cleaved correctly and whether there are any scratches or contamination on the connector end surfaces. This tool provides a simple and cost-effective way to inspect cleaved fiber ends and connector end surfaces in the field. It is the twelfth in a bimonthly series on the theme of practical field information about telecommunication technologies. This month's contribution is from the Access Engineering Group, Technical Assistance and Support Center, Maintenance and Service Operations Department, Network Business Headquarters.

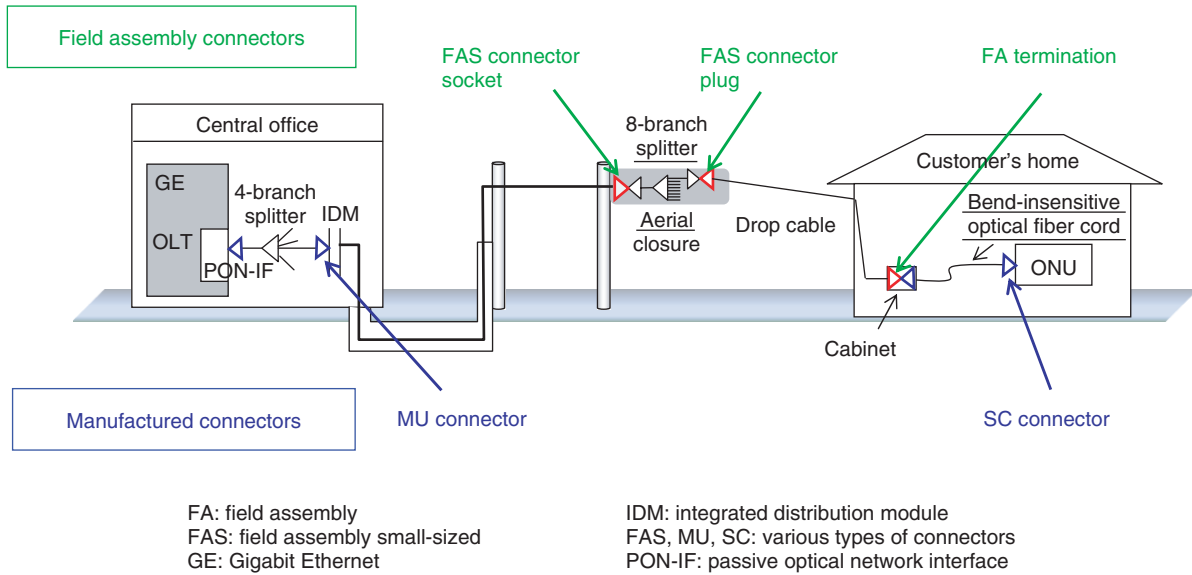
Fig. 1. Use of optical connectors in FTTH.

FTTH is illustrated in **Fig. 1**. From the optical line terminal (OLT) located in the central office, underground cables and aerial cables transmit signals to optical network units (ONU) located in customers' homes. That configuration requires many connection points. Optical connectors are used in the central office, outdoors, and in customers' homes. For each connection point, either a connector produced in a factory (manufactured connector) or a connector assembled in the field (field assembly connector [1]) is chosen and used as appropriate.

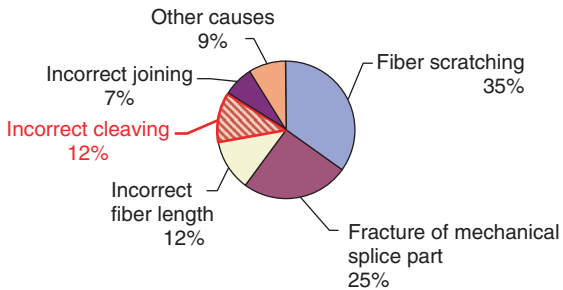
Fig. 2. Causes of field assembly connector faults.

In our investigation of fault causes, we collected actual defective field assembly connectors from an area of Japan and checked their optical characteristics and dismantled them to identify the cause of the fault [2] (**Fig. 2**). 12% of the faults were caused by increased optical loss due to incorrect cleaving of the optical fiber. An incorrectly cleaved fiber end is shown in **Fig. 3**.

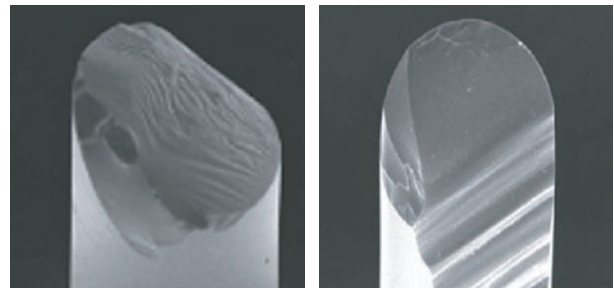
Fig. 3. Cleaved fiber ends.

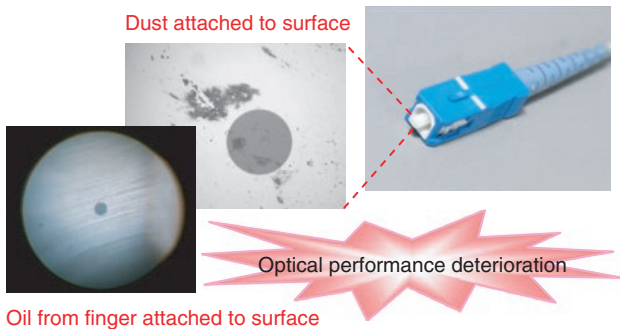
Fig. 4. Causes of manufactured connector faults.

Investigating the causes of faults of manufactured connectors, we found that contamination of the connector end surface by dust or finger oil or damage

from scratching deteriorated the optical performance and resulted in a fault (Fig. 4).

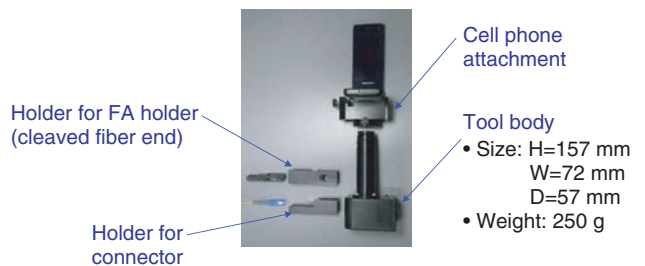
Fig. 5. Configuration of the developed tool.

The configuration of the inspection tool is shown in **Fig. 5**. For low cost and high generality, the tool is composed of three main parts: a body that includes a microscope, a cell phone and its attachment, and special holders for cleaved fiber ends or connector end surfaces.

The tool body is 157 mm high, 72 mm wide, and 57 mm deep and its weight is 250 g, so it is easy to use with one hand.

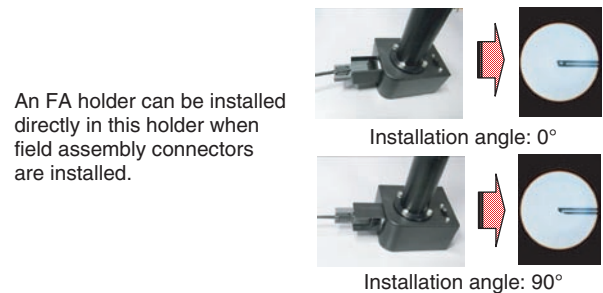
Fig. 6. Holder for FA holder.

The holder for cleaved fiber ends is used to install the FA holder used in field assembly procedures. It can be used to check the cleaved optical fiber ends from four directions ( $0^\circ$ ,  $90^\circ$ ,  $180^\circ$ , and  $270^\circ$ ), so incorrect cleaving can be easily identified (**Fig. 6**).

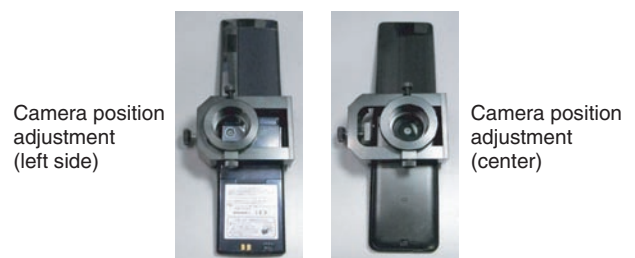
Fig. 7. Cell phone attachment.

The cell phone attachment has a horizontal adjustment slide that we developed to cope with different types of cell phones having cameras in different locations. It ensures that the cell phone's camera lens can be aligned with the tool's microscope regardless of the type of cell phone being used (**Fig. 7**).

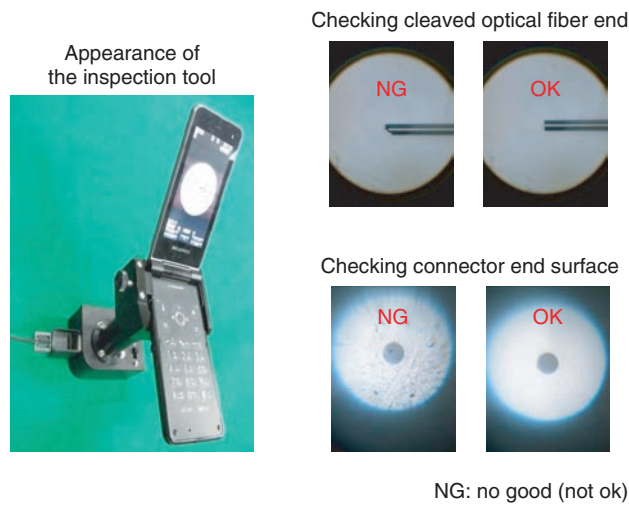
Fig. 8. Results of visibility evaluation.

The developed inspection tool and the results of checking cleaved optical fiber ends and connector end surfaces with the cell phone display are shown in **Fig. 8**. We can clearly see whether there are any defects in the cleaved fiber ends or any contamination on the connector end surfaces, confirming that it is possible to check the quality of the work visually.

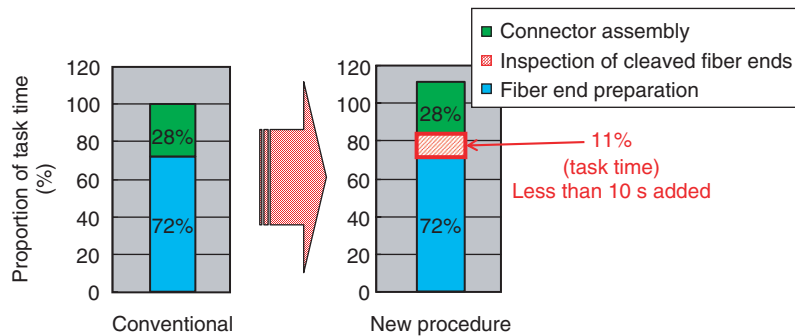
Fig. 9. Results of work evaluation.

Evaluation of the time required for the inspection of the cleaved fiber ends revealed that preparing the optical fiber end accounted for 72% of the task time and assembling the connector accounted for 28% of the time before the introduction of the cleaved-fiber-ends inspection. Adding the cleaved-fiber-ends

inspection task extended the time by 10 s, taking 11% of the entire work time. This result confirms the workability of the inspection (Fig. 9).
