Practical Field Information about Telecommunication Technologies

Case Studies of Telecommunication Problems Caused by Conducted Disturbance in AC Power Lines

Technical Assistance and Support Center, NTT EAST

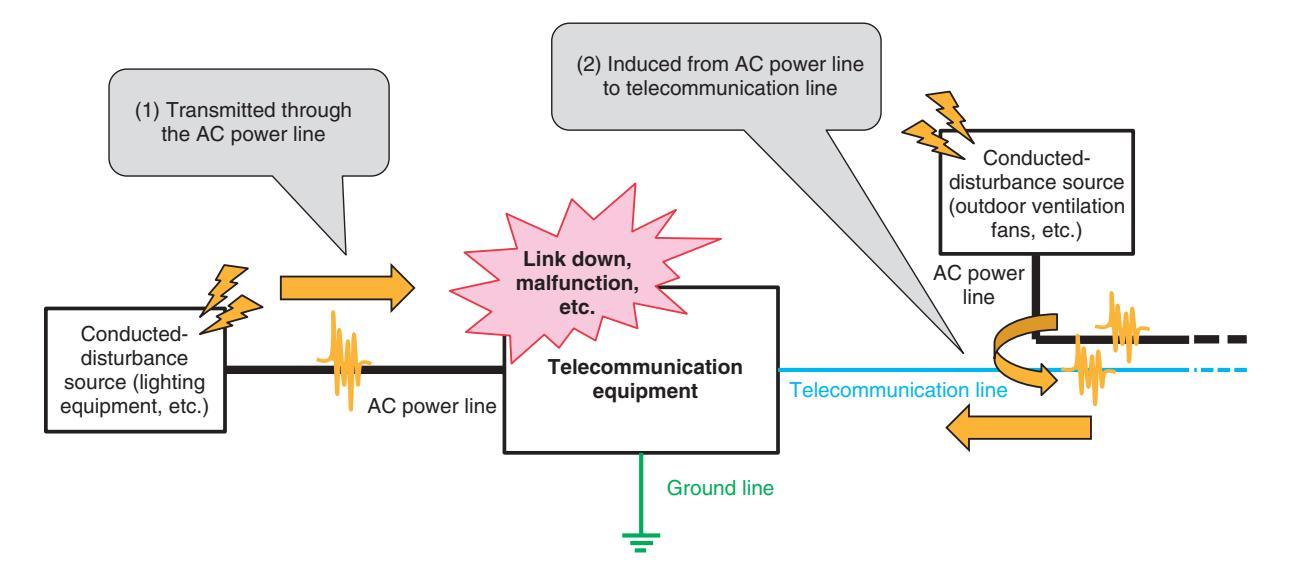
Fig. 1. Infiltration paths of conducted disturbance in AC power lines into telecommunication equipment.

Conducted disturbance in AC power lines can infiltrate telecommunication equipment through AC power lines and telecommunication lines. As shown in **Fig. 1**, conducted disturbance in AC power lines can infiltrate telecommunication equipment through two paths: (1) direct transmission through the power line of the telecommunication equipment and (2) induction from another (nearby) power line into the telecommunication line.

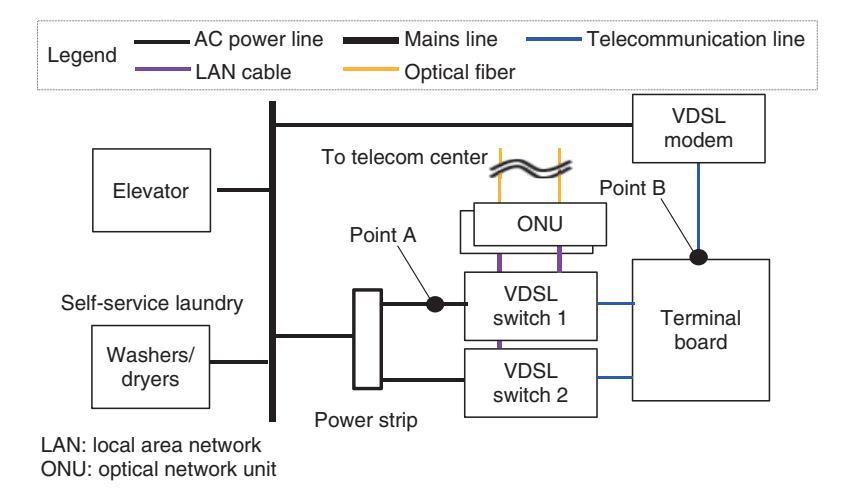
Fig. 2. Configuration of equipment.

The configuration of equipment in the apartment building is shown in **Fig. 2**. Two VDSL switches are connected to the same AC power line, and

telecommunication lines are wired from the VDSL switches through the terminal board to the VDSL modem. The elevator and washers/dryers located in a self-service laundry annexed to the first floor of the building shared the same AC power-distribution system with the VDSL switches.

To confirm the conducted disturbance interfering with the VDSL switches, we used an oscilloscope (DLM4058 from Yokogawa Electric) to measure the voltage between the cold line of the AC power line and ground line of VDSL switch 1 (Point A in Fig. 2) and the voltage between L1 on the telecommunication line and the ground line (Point B in Fig. 2). We found conducted disturbance up to 8 Vpp on the AC power line when the link down occurred (Fig. 3). However, no obvious conducted disturbance on the telecommunication line was found. When the measured conducted disturbance was subjected to fast Fourier transform (FFT) processing, a fundamental frequency of 10 kHz (red circle in Fig. 4) and its harmonics were observed. The fundamental frequency and third harmonic had the highest conducted-disturbance level, i.e., -4 dBV.

Since we confirmed that conducted disturbance was interfering with the VDSL switches, we investigated the source of the disturbance by focusing on the elevator and washers/dryers installed in the laundry, which share the same AC power line with the VDSL switches. However, we could not conduct measurements in the power-supply control room, so we operated the elevator and washers/dryers and investigated the generation of conducted disturbance at point B in Fig. 2.

noise filters for AC power lines (NCT-i3 from DEN-KENSEIKI Research Institute and CNF-5A from SANRITZ ELECTRONICS), each was installed on the AC power line (at point A in Fig. 2) in separate tests when the washer/dryer was operated for 20 minutes. We confirmed that the link down did not occur in VDSL switch 1 regardless of which filter was installed.

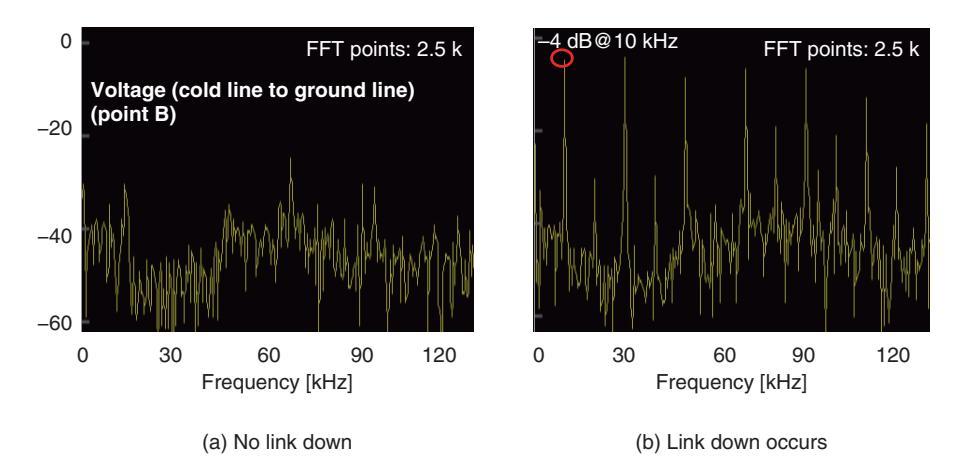
Fig. 4. Measured waveforms of conducted disturbance (FFT-processing results).

The results of the investigation suggested that the link down was caused by conducted disturbance of 10 kHz generated from one large washer/dryer, which was interfering with the VDSL switches through the AC power lines. As a countermeasure, it is necessary to inspect and repair the washer/dryer, which is the source of conducted disturbance. To suppress the impact of conducted disturbance during the investigation period, however, we implemented a countermeasure using noise filters for VDSL switch 1 and investigated its effectiveness. We tested two different

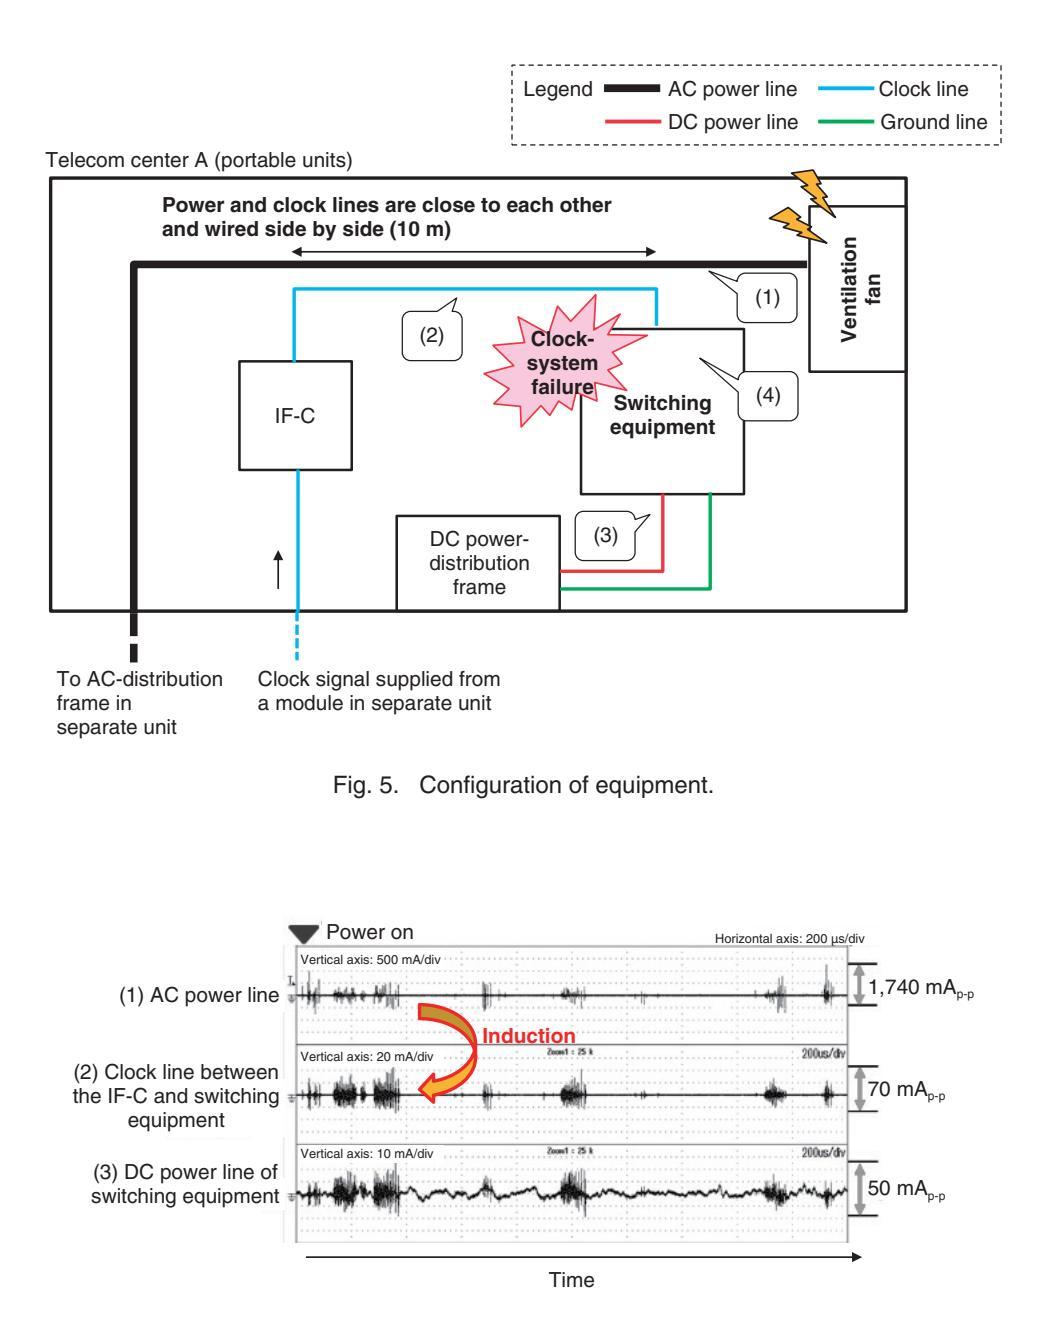
Fig. 6. Measured waveforms of conducted disturbance.

The measurement results are shown in **Fig. 6**. When the ventilation fan was turned on, conducted disturbance of 1740 mApp was generated on the AC power line (1). In synchronization with that conducted disturbance on the AC power line, conducted disturbances of 70 mApp on the clock line (2) and 50 mApp on the DC power line (3) were also measured.

From the investigation results, it was found that the clock-system failure was caused by conducted disturbance from the ventilation fan, which was propagated through the AC power line and induced into the clock line.

As a countermeasure, it is necessary to eliminate the effect of the induction of conducted disturbance by re-routing the clock line. However, it was not possible to reroute the clock line during the investigation period; therefore, we installed a noise filter on AC

power lines (GT-215J from KEMET) between the ventilation fan and AC power line and a ferrite core (E04SRM from SEIWA ELECTRIC) on the clock line. We confirmed that the clock-system failure no longer occurred when the ventilation fan was turned on or off.

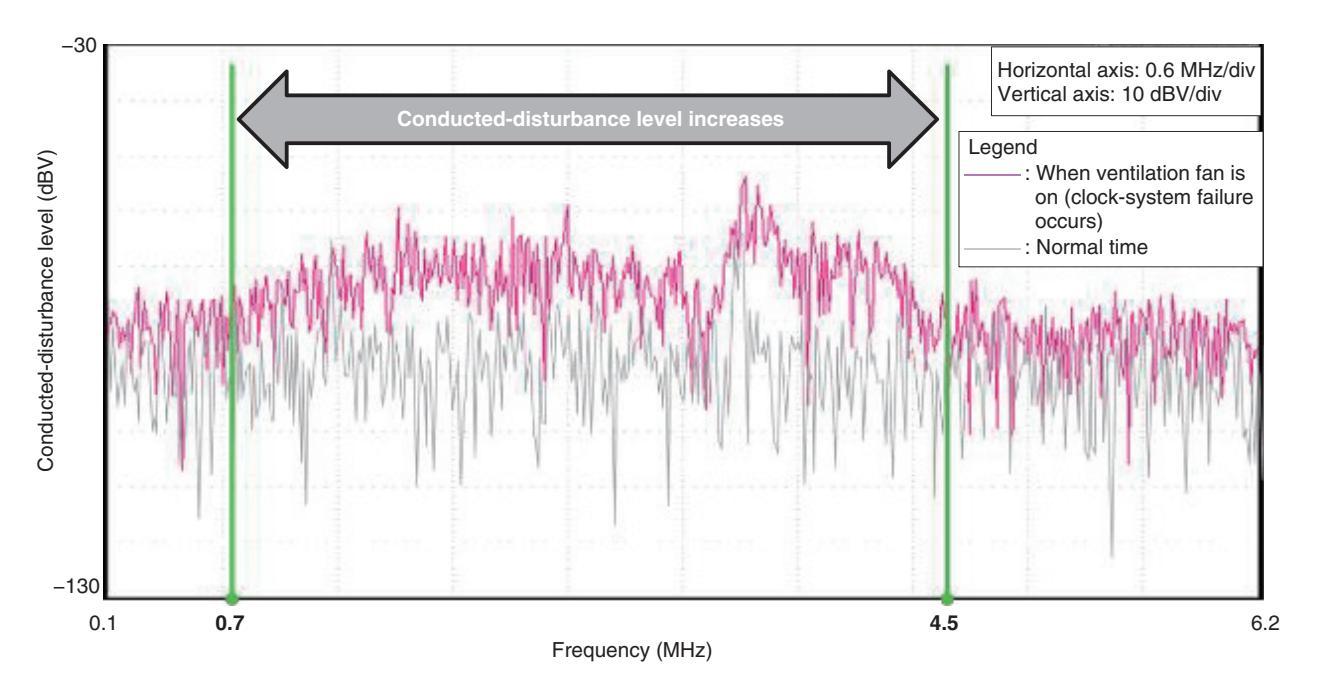
Fig. 7. Measured waveforms of conducted disturbance (FFT-processing results).

The analysis results of applying FFT processing to the measurement (2) are shown in **Fig. 7**. These results indicate that the conducted-disturbance level increased in the 0.7–4.5-MHz range.
